The Trailing Edge

April 2023

When Things Move That Shouldn't...

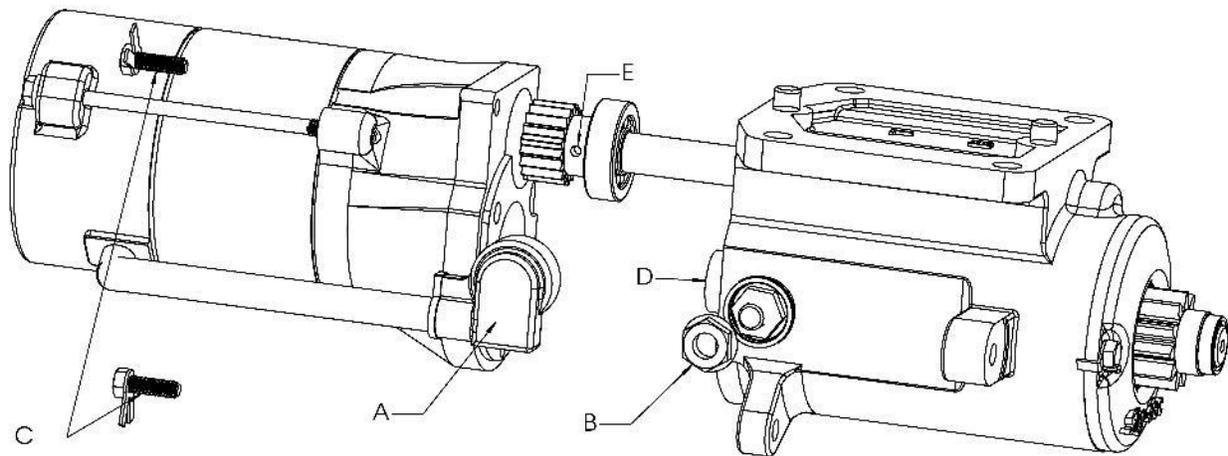
In the drawing above, the two halves of the starter are shown separated. These two halves are held together by two (2), count them, two, M5x25mm hex screws (part “C” in the above figure). For those of you not hip to metric fasteners, that’s roughly equivalent to an AN3 bolt (3/16 inch diameter) 1 inch long. Not very big. I assume there are some bosses where the two parts join to absorb the torque of the motor and the screws just hold the parts together. These hex head screws were torqued in place and retained by metal anti-rotation tabs. This system was actually the fix to the original design of Phillips head screws with lock washers.

I was told that the locking tabs on the screws were not strong enough to prevent the screws from loosening in the high vibration environment that the starter lived in. Time for some recreational maths. The thread pitch on an M5 screw is 0.8 millimeters. If we assumed that the screw backed out one-sixth of a turn (i.e. one flat), that would mean that the screw would move out 0.1333 millimeters, or 0.005 inches (i.e. “five thousandths”). That’s about the same thickness as a “normal” 20-pound sheet of printer paper. Since the screws are only torqued to 50 in-lbs, it is not surprising that they would back out under that much vibration.

Looking at five thousandths on my calipers looked very similar to what I saw on the starter. When things are supposed to have zero clearance and they have five thousandths clearance, that’s a problem. It is clear that the bent metal tabs will keep the screws from fully backing out, but they won’t prevent all movement. It looks like they can allow for about a sixth of a turn while still looking like they haven’t moved at all. An interface with a gasket might be able to absorb this change, but these are two machined surfaces intended to have zero clearance.

The latest redesign is to use thread locker (such as Loc-Tite) and lock washers. He said they haven’t had any problems since doing that. He had me fill out a warranty claim form and sent me an RMA. Now I send in my starter (at my expense) and they will send me a “new” starter. I don’t know if that will be a “new” starter or if they will rebuild this one. Yes, I could probably tighten the existing screws and add lock washers and Loc-Tite, but if I send it in I feel like someone will inspect the starter to see if there is any other damage I might not know about. Airplane down time is not an issue since I expect it will be down for the condition inspection longer than it will take to get a replacement starter back.

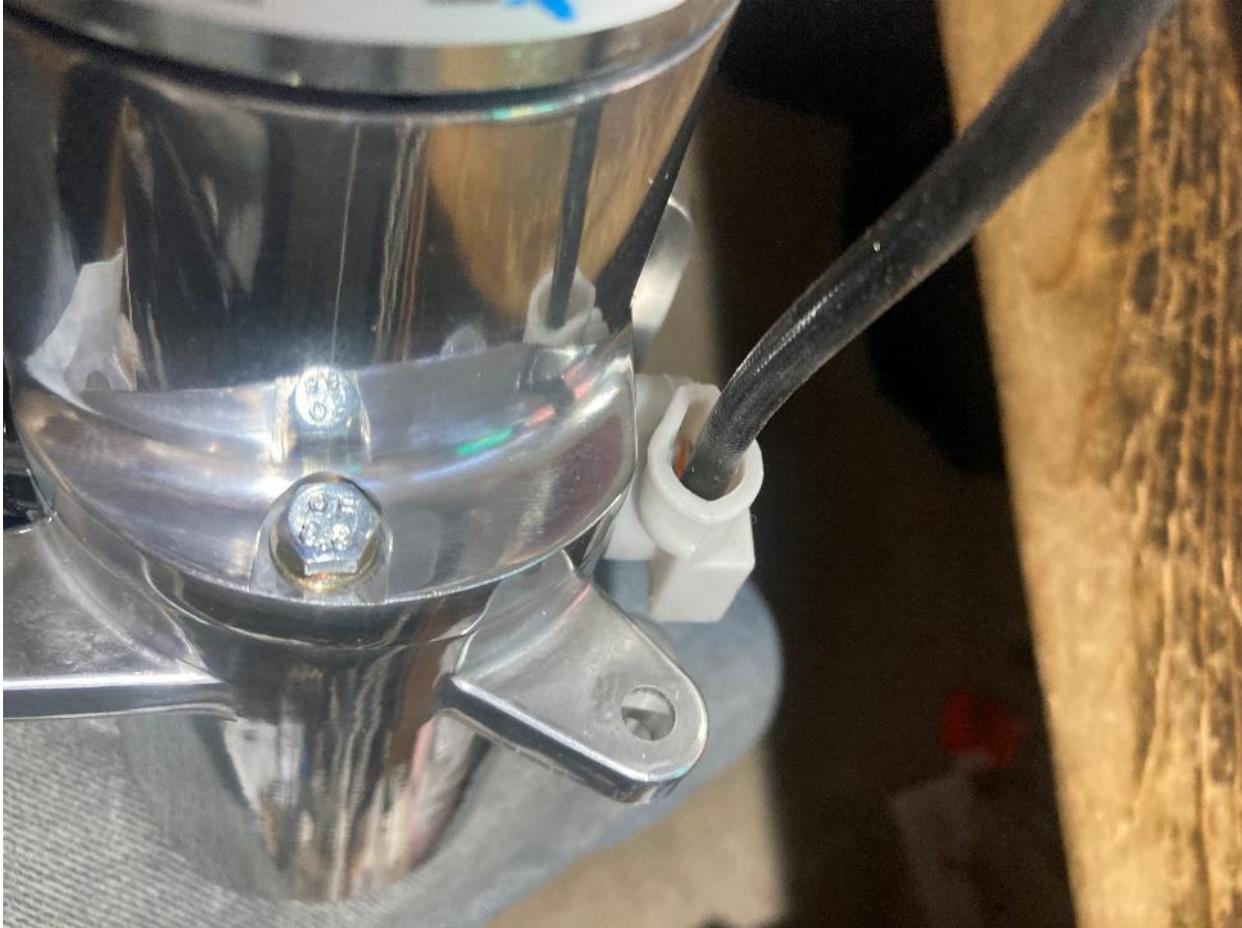
The starter was shipped back to Sky-Tec (at my expense). As they promised, Sky-Tec sent me a brand-new starter with a new serial number. This was a “warranty” repair and cost me no additional money. The new starter has the same screw with a lock washer under the head. I presume there is thread locker on the screw as I was told.
