The Trailing Edge

December 2024

Being Advanced Isn't Always A Good Thing

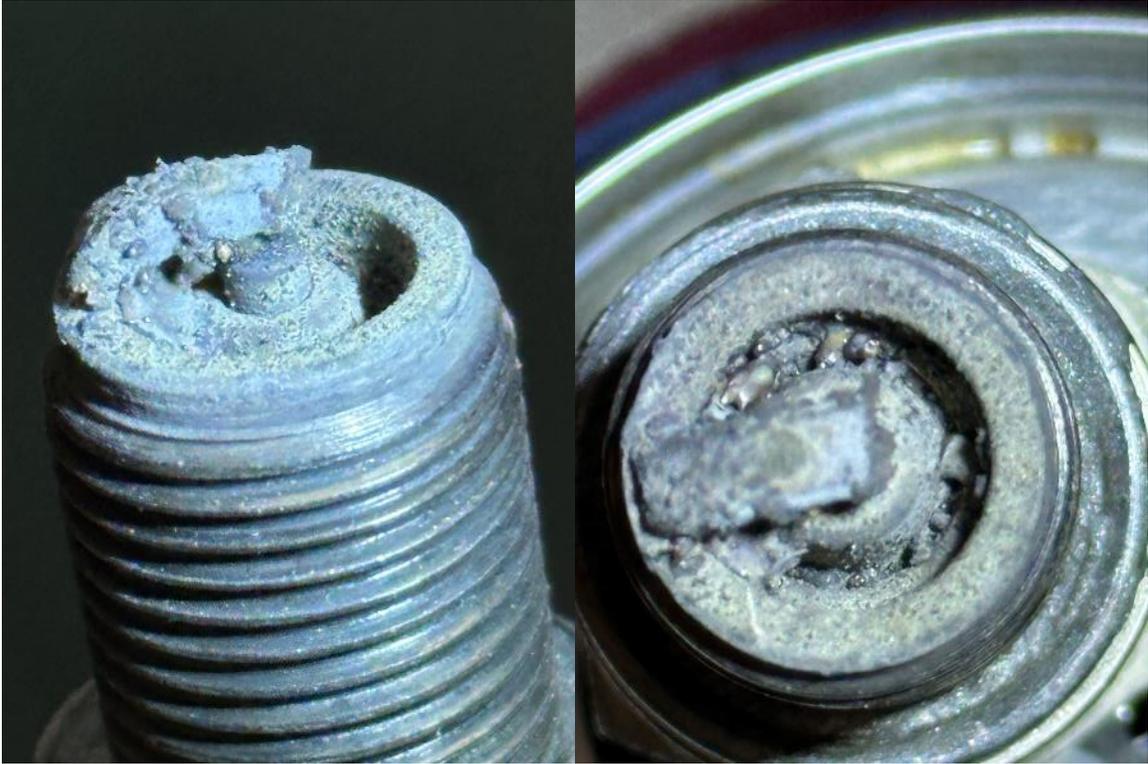
I posted the engine monitor data from the 23 December test flight to Savvy Analysis so that my analyst could see that everything was back to normal. To explain a sudden spike in the EGT trace, I mentioned to him that I had done an in-flight "mag check" at that point. Being the excellent analyst that he is, he looked at the traces to see if EGT increased when one of the ignitions was turned off. (EGT would increase because it takes longer for the whole fuel-air mixture to burn than when each spark plug only has to burn half of it. Because it takes longer, it hasn't cooled as much before going out the exhaust valve.) He noted that for one ignition, the EGT on cylinder #3 dropped when it should rise. He recommended that I check the spark plug for that ignition in cylinder #3. Since I didn't know which one it would be, I started with the lower plug, since I have only seen lead fouling on the lower plugs. Sure enough, the lower plug on cylinder #3 was heavily fouled, as seen in these pictures. Rather than try to clean the plug, I simply replaced it with a new plug.
