# *The Trailing Edge*

December 2024

## **Being Advanced Isn't Always A Good Thing**

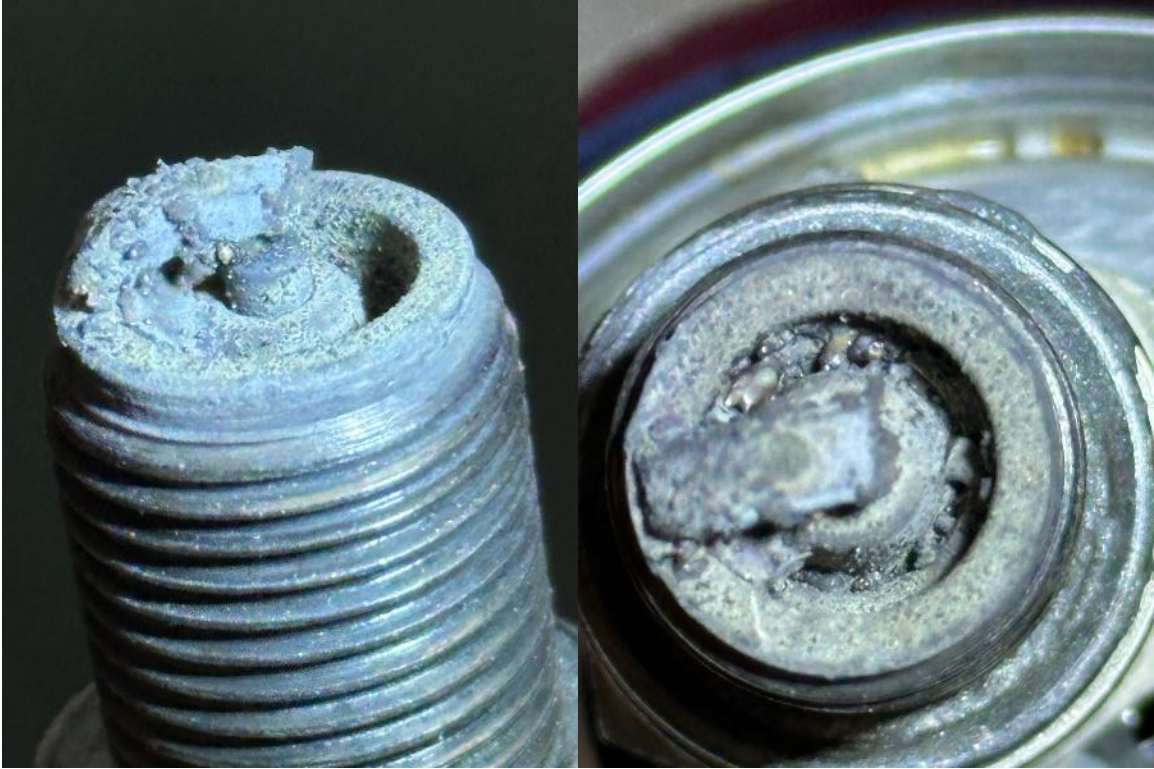
I posted the engine monitor data from the 23 December test flight to Savvy Analysis so that my analyst could see that everything was back to normal. To explain a sudden spike in the EGT trace, I mentioned to him that I had done an in-flight "mag check" at that point. Being the excellent analyst that he is, he looked at the traces to see if EGT increased when one of the ignitions was turned off. (EGT would increase because it takes longer for the whole fuel-air mixture to burn than when each spark plug only has to burn half of it. Because it takes longer, it hasn't cooled as much before going out the exhaust valve.) He noted that for one ignition, the EGT on cylinder #3 dropped when it should rise. He recommended that I check the spark plug for that ignition in cylinder #3. Since I didn't know which one it would be, I started with the lower plug, since I have only seen lead fouling on the lower plugs. Sure enough, the lower plug on cylinder #3 was heavily fouled, as seen in these pictures. Rather than try to clean the plug, I simply replaced it with a new plug.
