The Trailing Edge

June 2025

Bearhawk Alternator Field Replacement

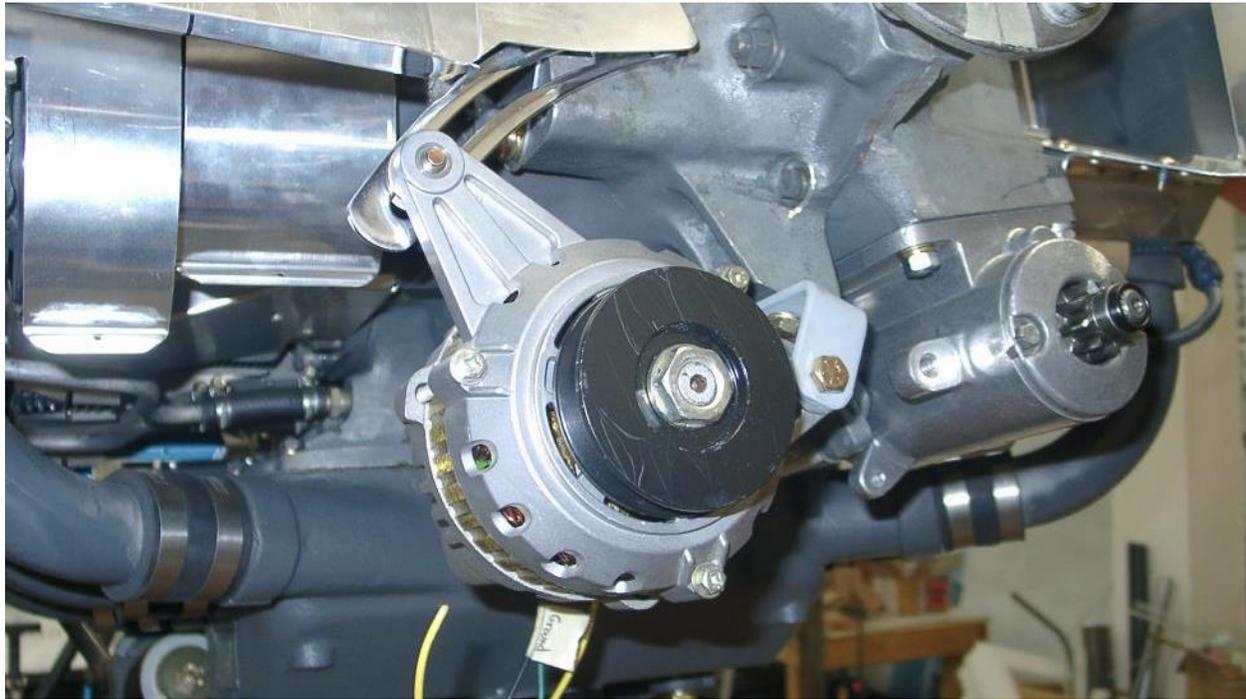
I bought this alternator for \$137 (in 2004). It was a 60 amp Mitsubishi alternator that had been converted for use with an external regulator. It looked fine to me at the time, but it was clearly built for automotive levels of vibration, not aircraft engine levels of vibration. I installed it and it worked fine...initially.

60 amp converted Mitsubishi alternator modified for external regulation as originally installed

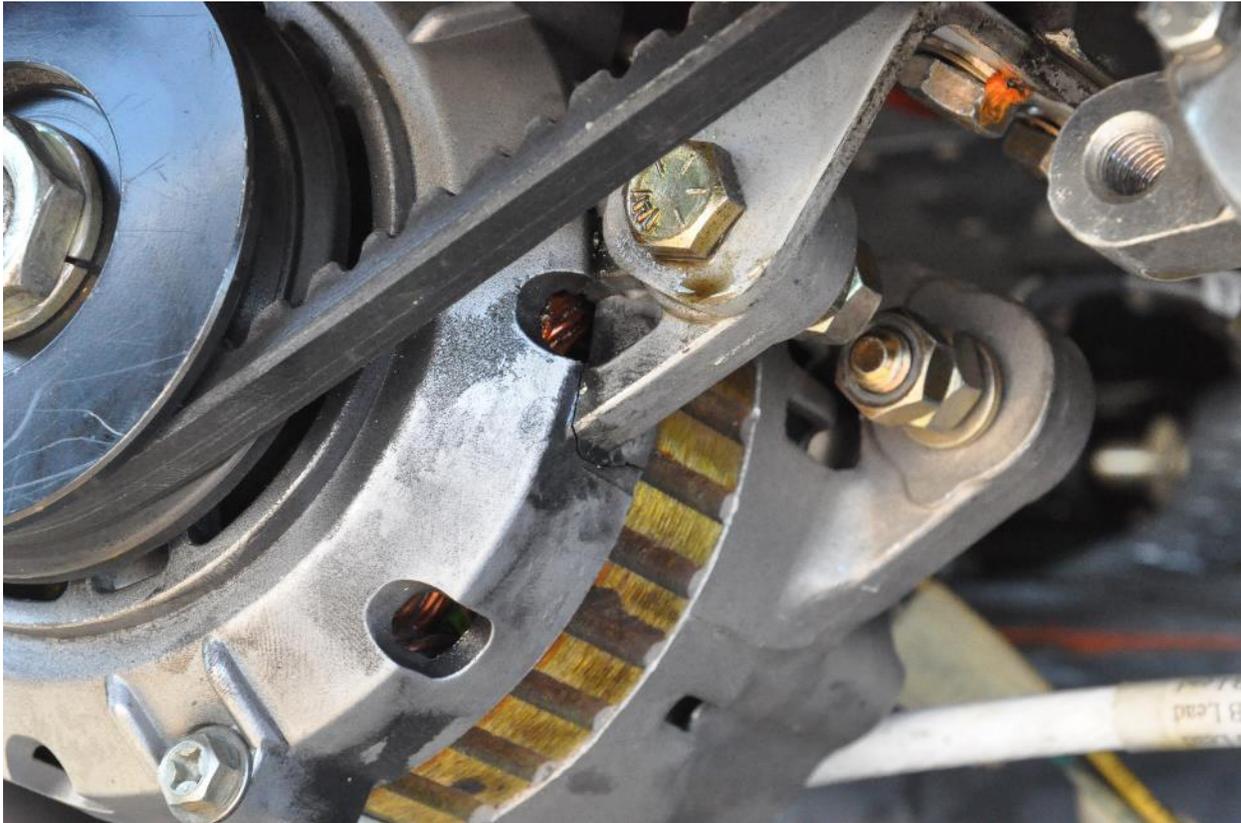
When we got the lower nose bowl removed, the problem was immediately obvious. Of the two brackets attaching the alternator to the engine block, the rear one had fatigue cracked itself into two separate pieces, thus allowing the alternator to move when I pushed on the belt. Additionally, the front mounting boss on the alternator had fatigue cracked itself free of the alternator casing. It's not clear which failure happened first, but a failure in either one would transfer the loads to the other one, causing the second failure. Apparently, this was in a very high vibration environment, because the alternator only had about 40 hours on it.

Note the crack around the base of the front mounting boss

With the bracket at least temporarily repaired, we investigated the mounting boss. Yes, it was cracked, but it seemed to be staying in position. It seemed that it had cracked in a somewhat conical fashion. As long as the boss and the alternator case were kept in compression, they would stay together. I pulled some safety wire out of the WRSK kit (yes, that's redundant) and wrapped it around the alternator body and the mounting boss in such a way that they would remain pressed together. You've heard of Barnstormers maintaining their airplanes with bubble gum and baling wire? This was very much the modern equivalent. Actually, the safety wire probably didn't do much more than increase my confidence that the boss would stay in compression. Most of that actually came from the tension of the drive belt.

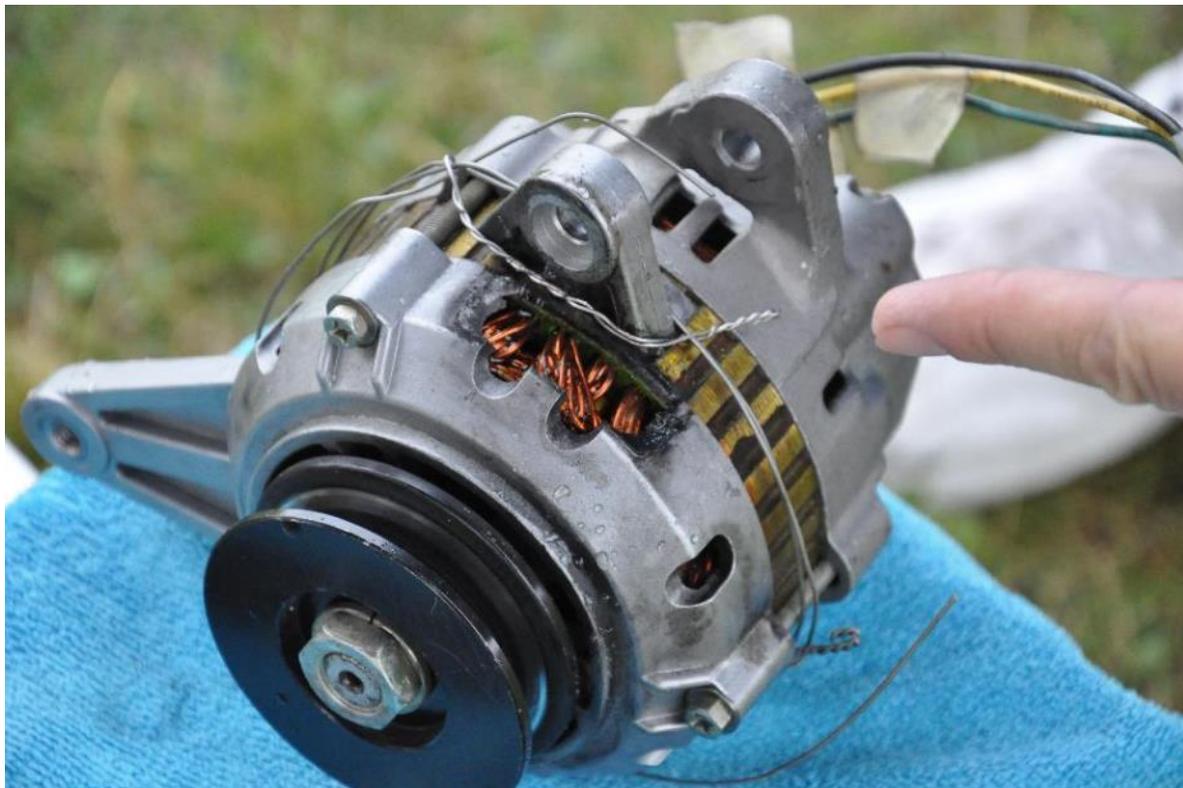
In this picture, the alternator has just been removed from the engine, with the precautionary safety wire still attached. The broken boss has been pulled out to show the extent of the damage.

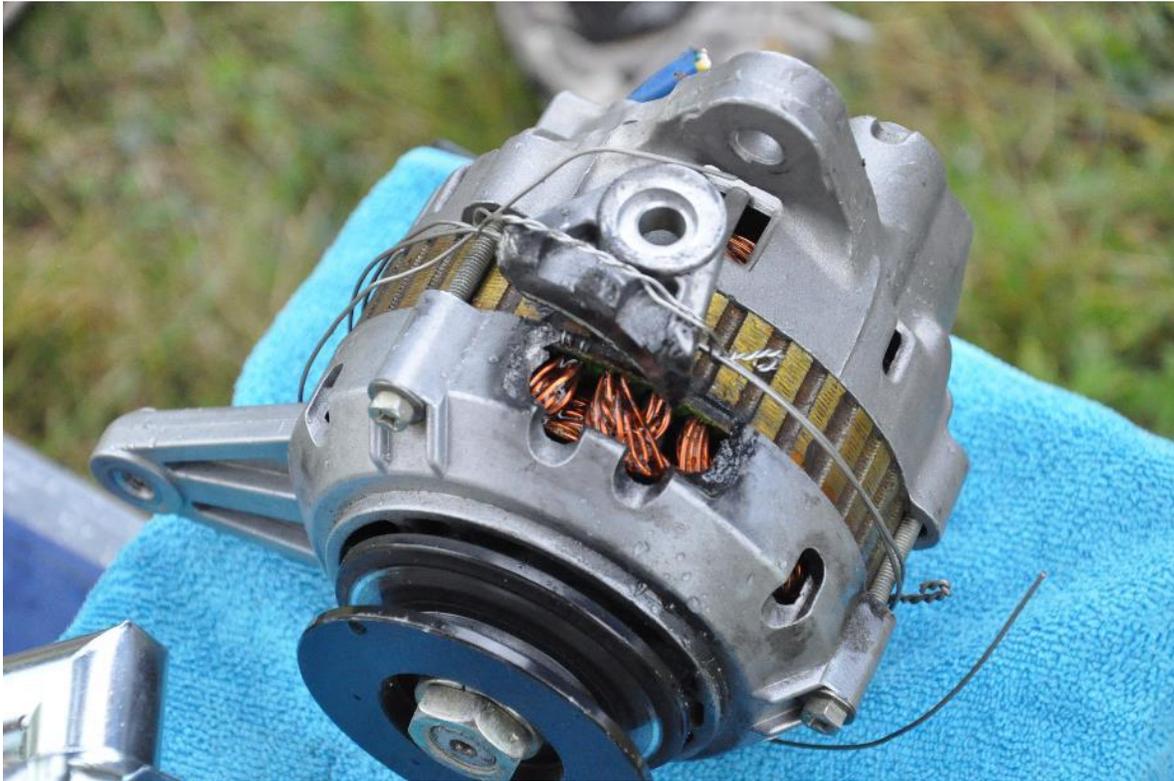
In this picture, the broken boss has been laid over to show the unusual but fortunate conical break that allowed the boss to continue to support the alternator as long as it continued to be pressed against the case. Additionally, the wiring harness has been cut from the alternator.

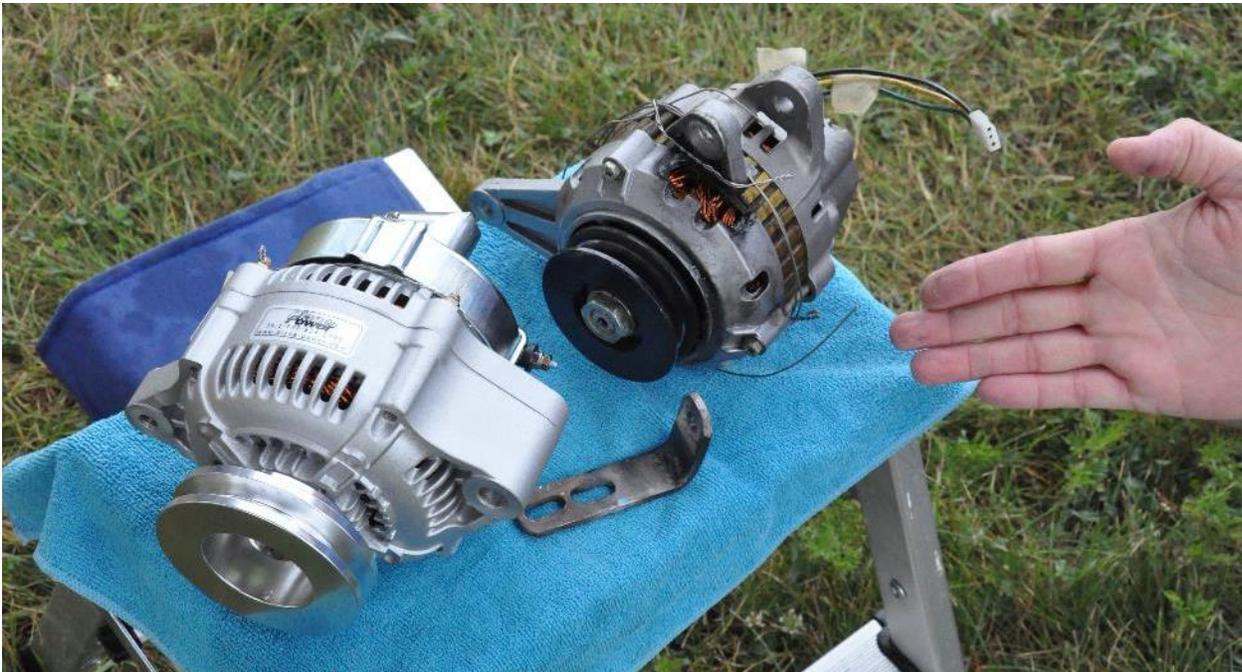
Here we see the old busted alternator (BOO!) and the new, pretty alternator (YAY!). The new alternator clearly has a much beefier construction, giving confidence that it will stand up much better to the high vibration environment attached to the Lycoming propulsion package. And it has—as of this writing, the Mitsubishi alternator lasted no more than 40 hours in service. The Plane Power alternator has operated for over 850 hours with no signs of degradation.

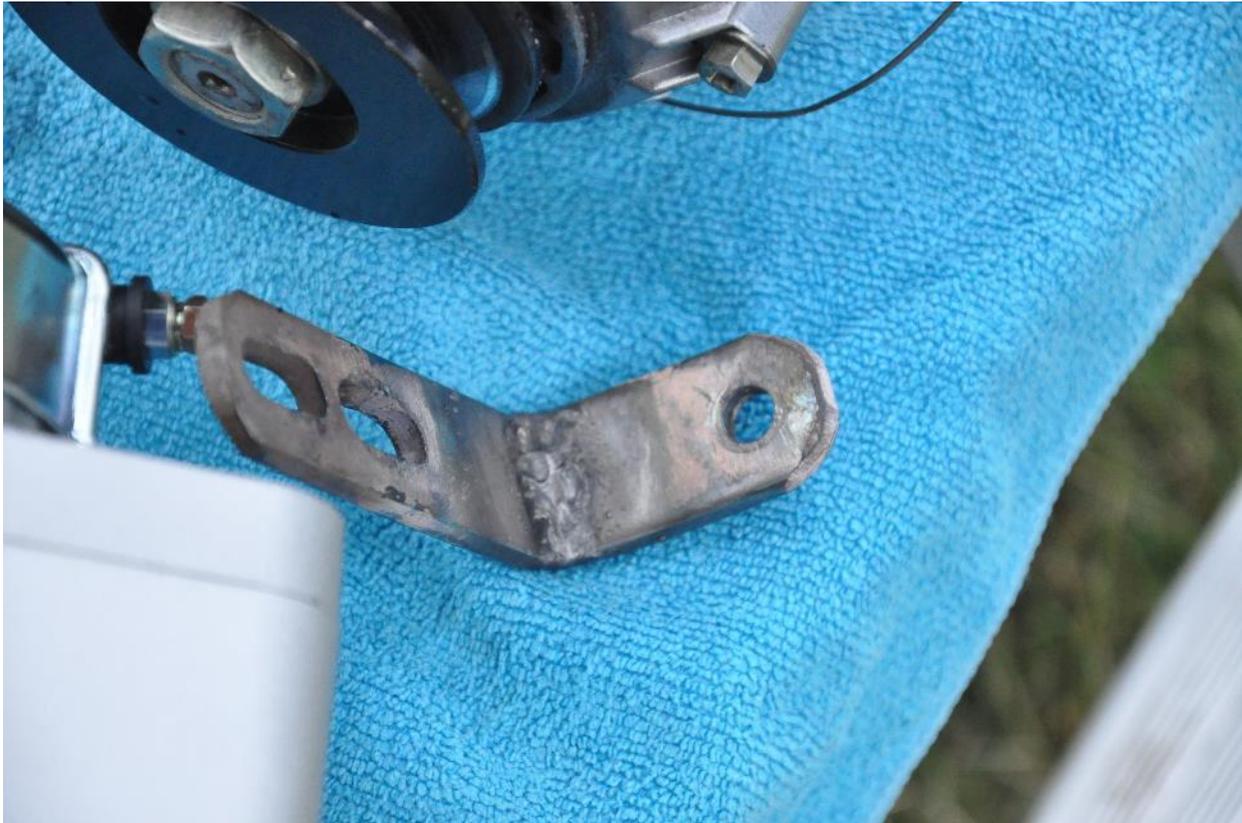
This is the rear bracket for the Mitsubishi alternator that was repaired by welding at KRAP. It appears to be 0.125 inch (1/8 inch) thick steel.

We asked if there was a maintenance shop on the field at KRAP. There was, but it was normally closed on Sundays. Fortunately, however, there was a jet on the field that morning that needed a repair to fly its scheduled mission, and they had already called out the mechanic to the field. Also, fortunately, the severed bracket was made of steel, so the mechanic was able to weld it back together. Since the jet had already paid the callout fee, he only charged me for the repair.

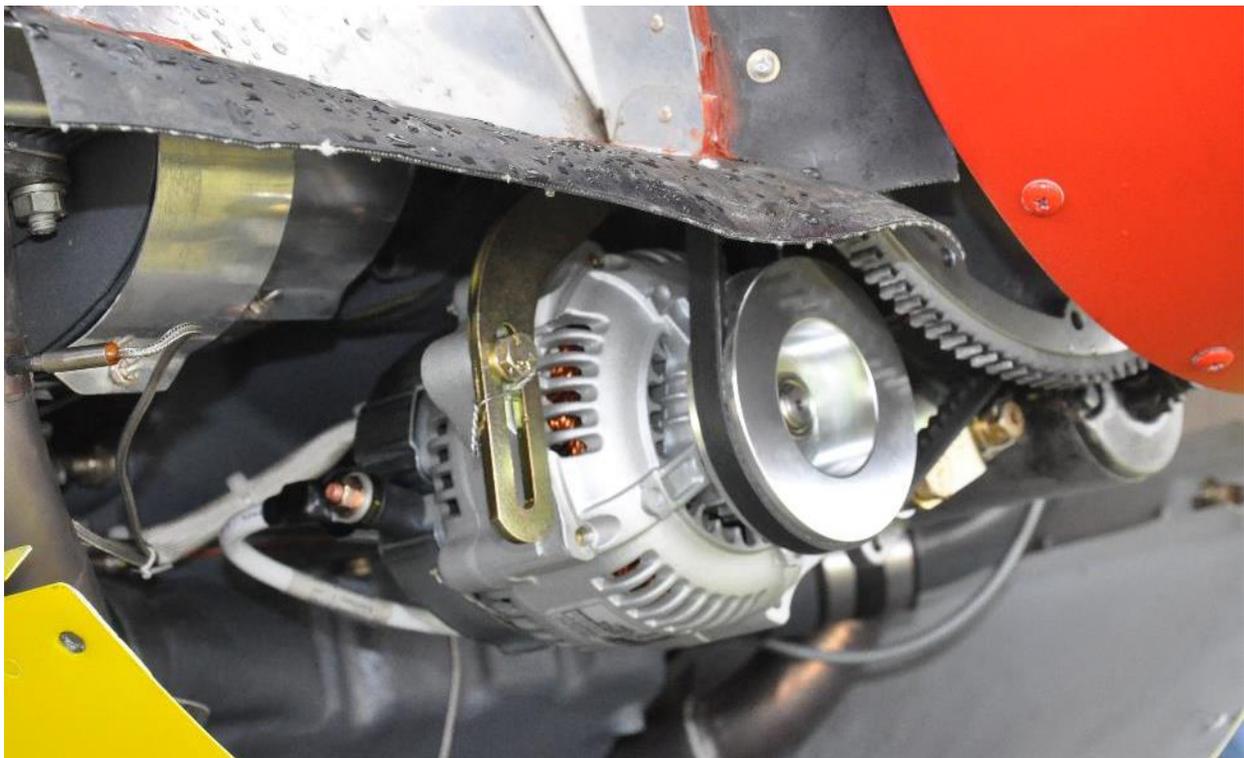
With the alternator tensioned, we see that I lucked out—just barely. If the drive belt had been any shorter there would not have been room left in the adjustment arm to attach the alternator.
