# *The Trailing Edge*

May 2022

## **Flying a Piece of History – C-53D Skytrooper**

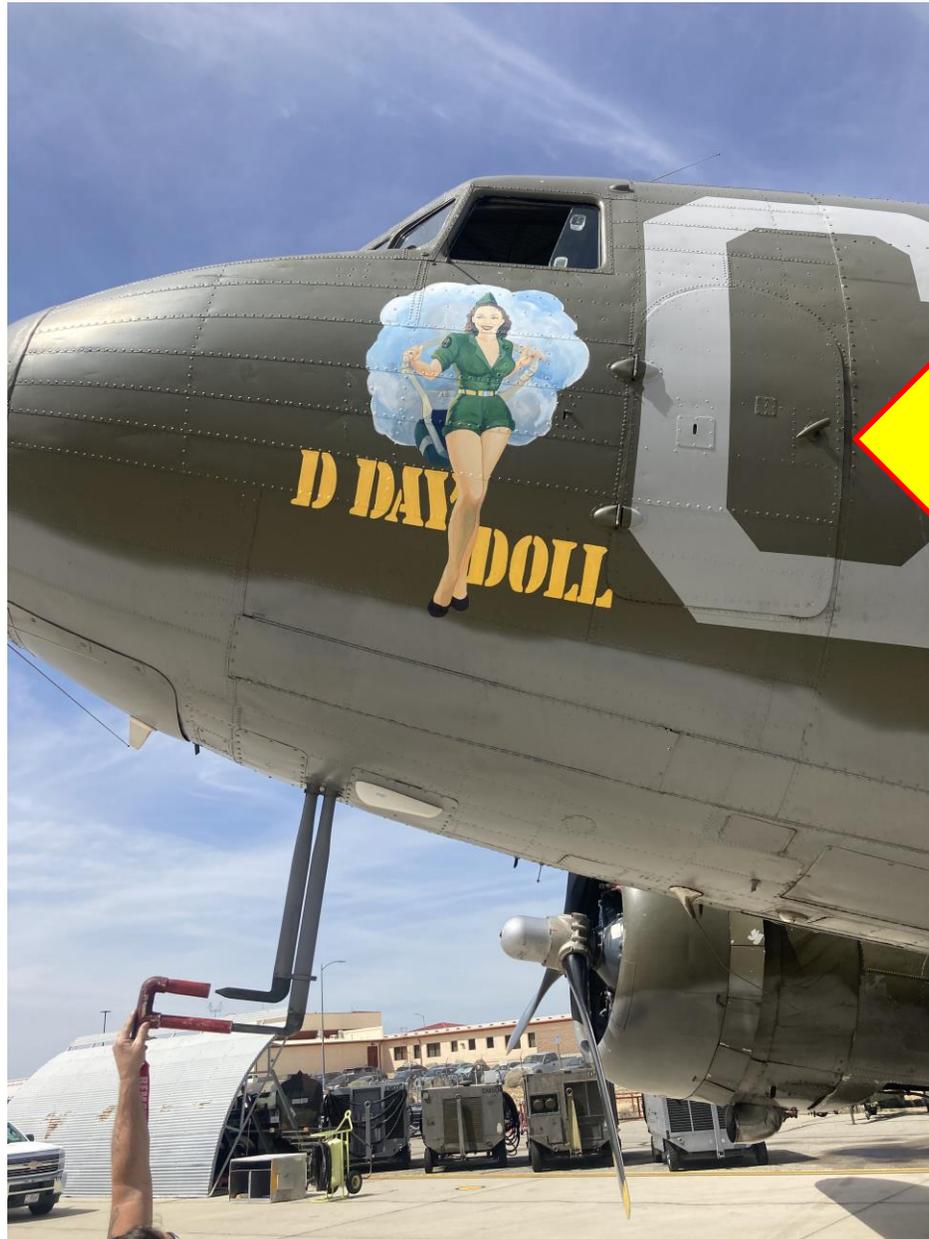
Right behind the nose art was a door colloquially referred to as the “hamburger hatch”. I used to think that this was the private entry door for the pilots, but I had not seen any pictures with ground support equipment that would provide stairs to get to this door. As explained by the crew, in the days the DC-3 was designed, airlines made a substantial part of their income from hauling the U.S. Mail. Regulations required a secure location for the mail away from the passengers and passenger baggage. For the DC-3, this location was right behind the cockpit. The regulations

also required that the postal clerk be able to access this secure location without passing through any passenger areas. As such, this door was included to allow secure access for the mail.

It was referred to as the “hamburger hatch” because it was located just forward of the left propeller, and if you opened this door while the left engine was running, you would likely be chopped up into hamburger. As it was, this door would not be convenient for entering the airplane anyway. The vertical dimension was shorter than a normal personnel door. Note how the top of the door was below the sill of the pilot’s window.

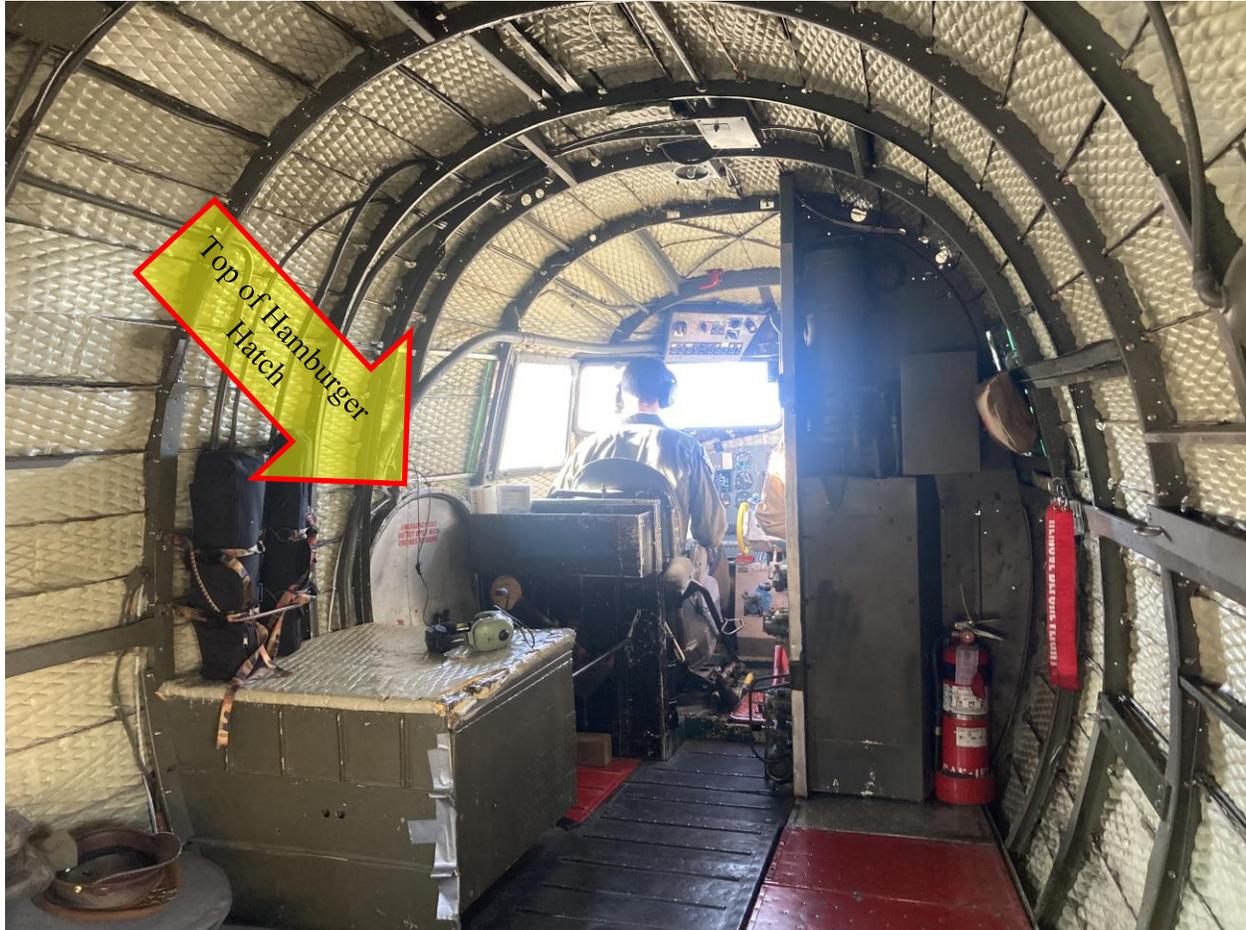
In this picture you can see the top of the “hamburger hatch” behind the pilot. The bottom of the door was actually below the level of the floor shown here. This door was not a preferred egress option because of its height above the ground, the proximity of the propeller, and the inconvenience of trying to go through it.

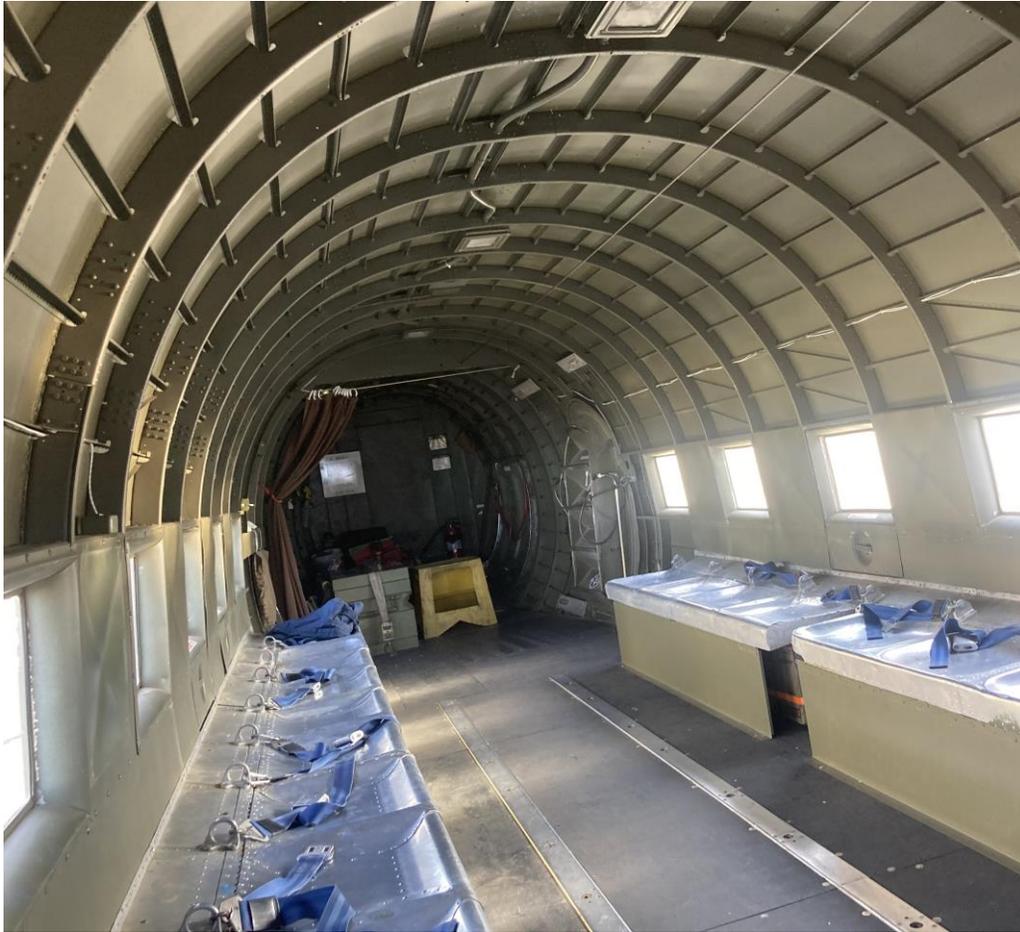
The airplane was set up as it was on D-Day, configured for jumping paratroopers. The seats were super comfy aluminum pans down both sides of the cabin. Overhead on the left side was the cable for attaching the parachute static line.

Note the integral stairs on the closed door. I assume that on jump missions the door would be removed, since the door opened outward. As this was not an airliner, no bulkhead was installed behind the door to separate the baggage area from the passenger area. In this airplane a curtain was installed at this location, shown drawn in this picture.

Three windows were configured as emergency exits. One can be seen on the far (aircraft left) side in this picture- the third window forward of the door has a twist handle under it. The panel around the window was hinged to the fuselage across the top. Two windows on the right side were configured the same way. Opening one of these exits resulted in a rectangular hole that was surprisingly small. I've heard people were smaller before WWII, but I can still imagine them having a hard time squeezing through that hole. Even if they did get through it, there was still quite a large drop to the ground.

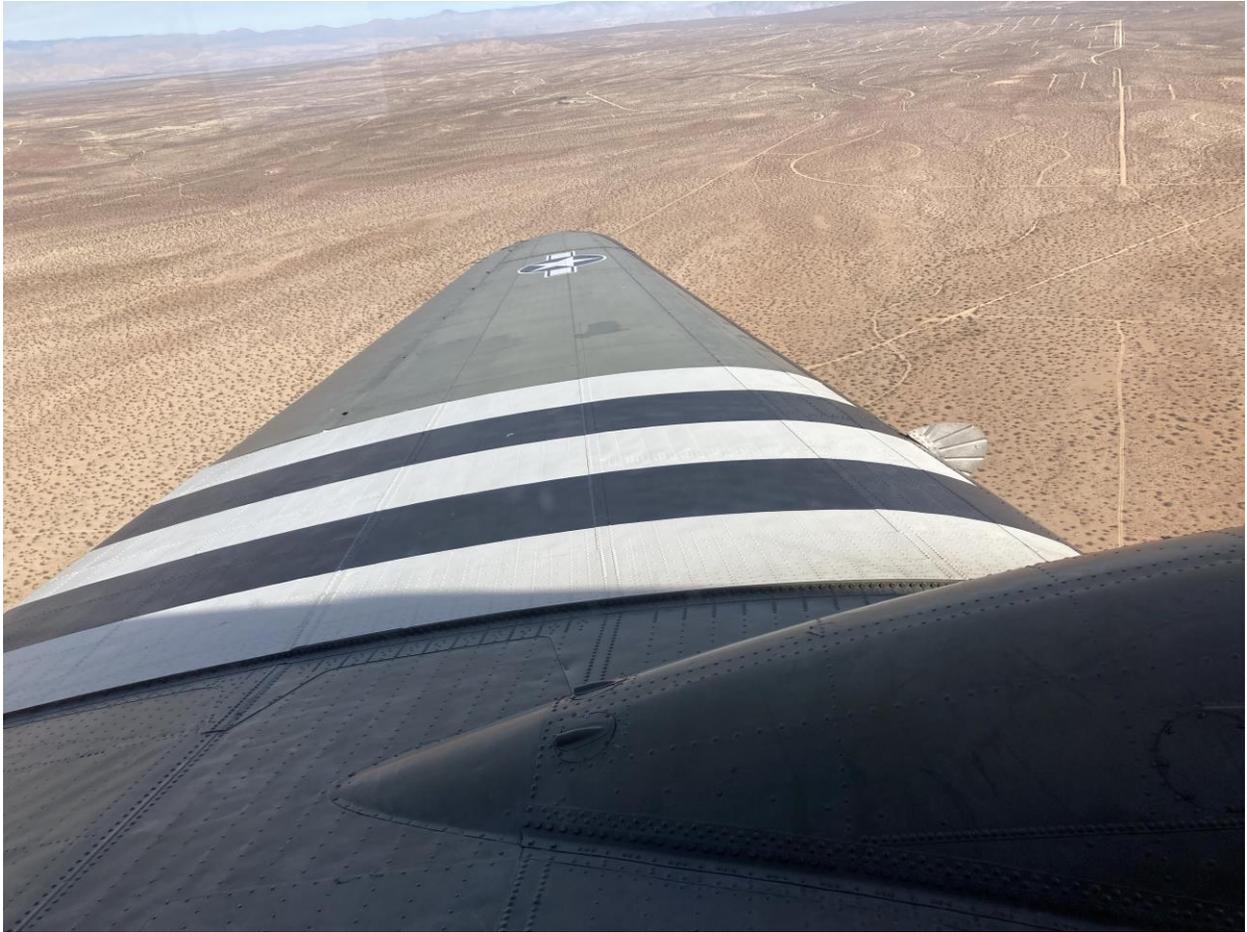
View down the left wing in flight. The aileron extends from the last white invasion strip all of the way to the wing tip. Given the size of this aileron, plus the one on the other side, it's not surprising that it would be hard to move it to full deflection using that little control wheel.

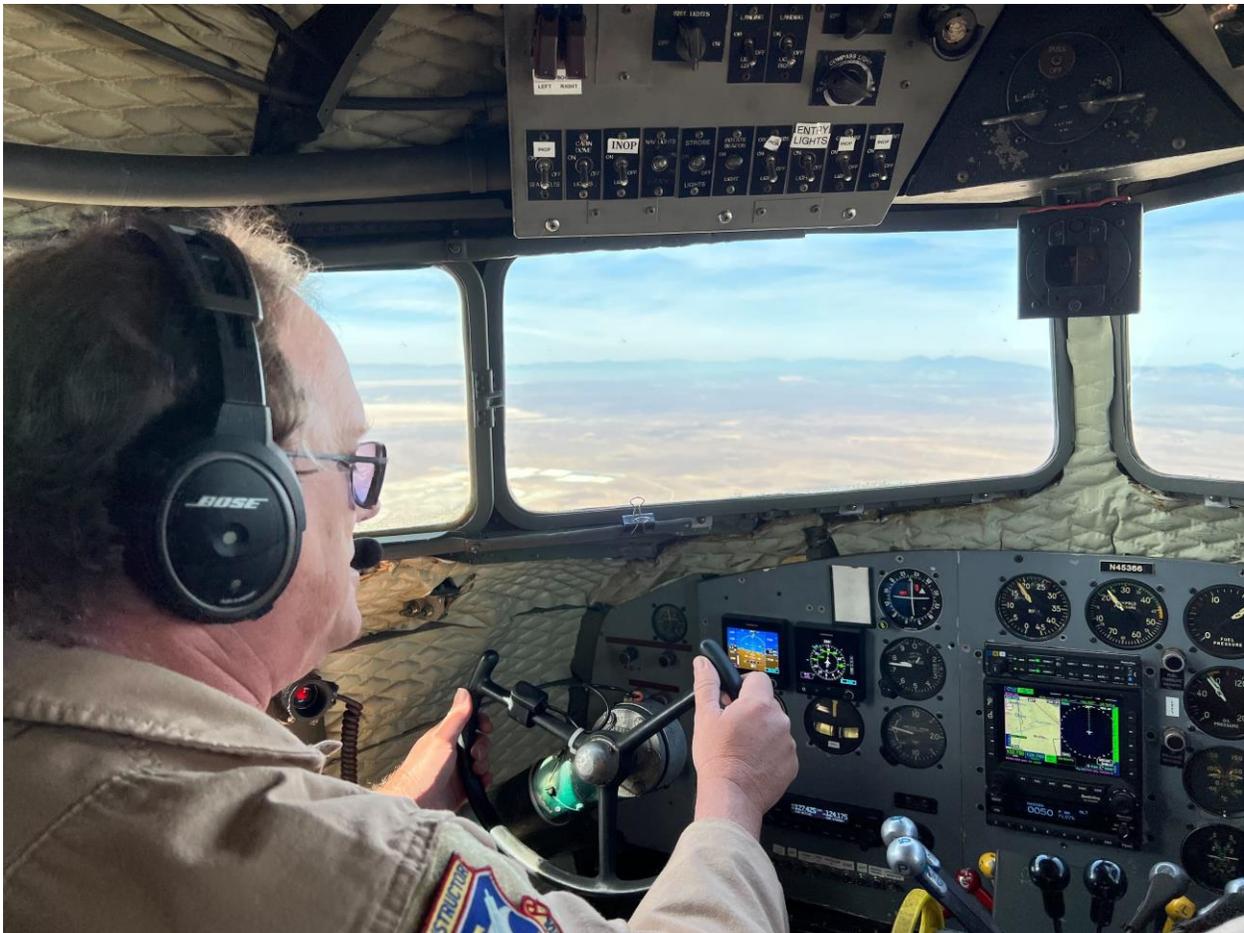
Here I am flying. Note the “period correct” glass displays and GPS navigator, which probably weren’t there in 1944. Then again, I wasn’t there in 1944, so I guess I’m not period correct either. Note also how the windshield is almost completely vertical—certainly good for visibility, as well as ensuring the airplane has sufficient drag to make the choice of engines worthwhile.

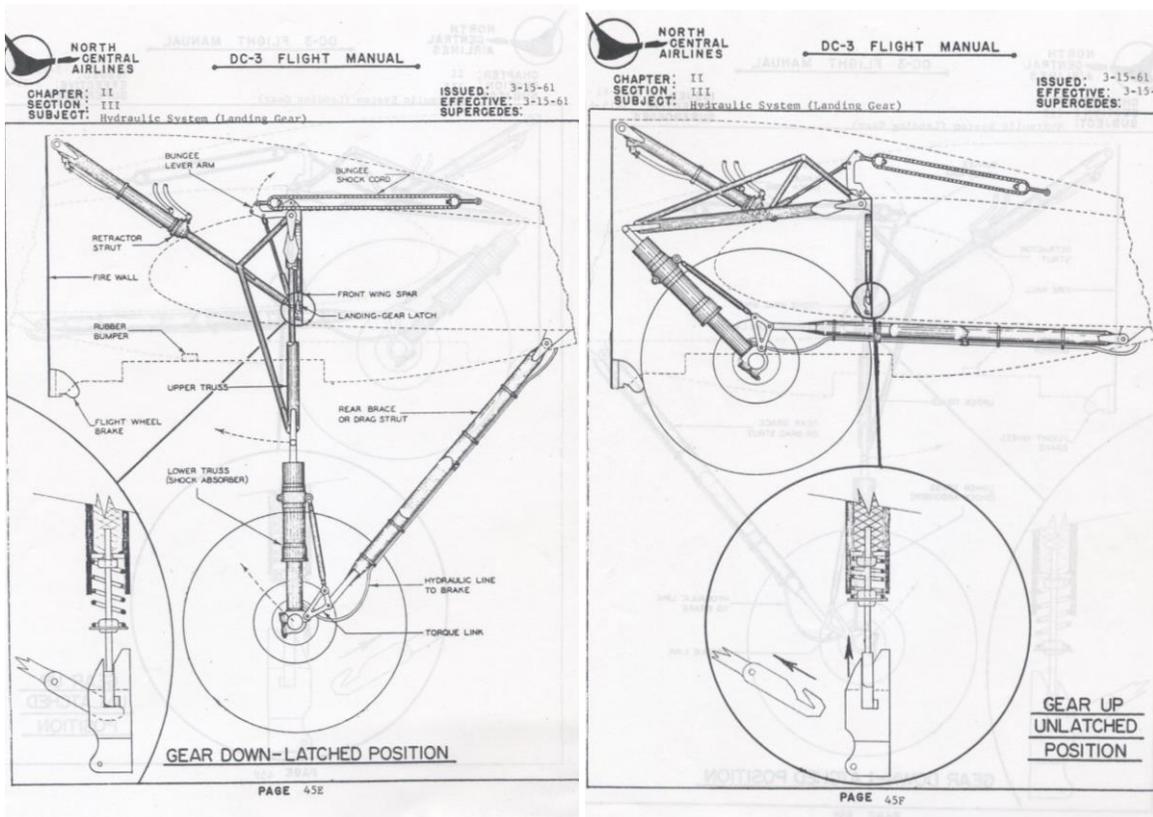
The basic gear leg holding the wheel was of a similar design to your own body's leg. There was an upper arm (similar to a thigh) and a lower arm (similar to a shin) connected together with a knee pivot joint. When the gear was down, these two arms were aligned, just like your leg when you are standing up. A hydraulic cylinder was connected to the center of the thigh, and when that cylinder shortens, it pulls the knee up, such that the retracted position resembles your leg while you are squatting.

There was a drag strut attached to the back of the “ankle” which keeps the knee from folding backwards (i.e. “kneeling”) while on the ground. The drag strut also guides the wheel up into the well and keeps the shin from flopping around under the knee.

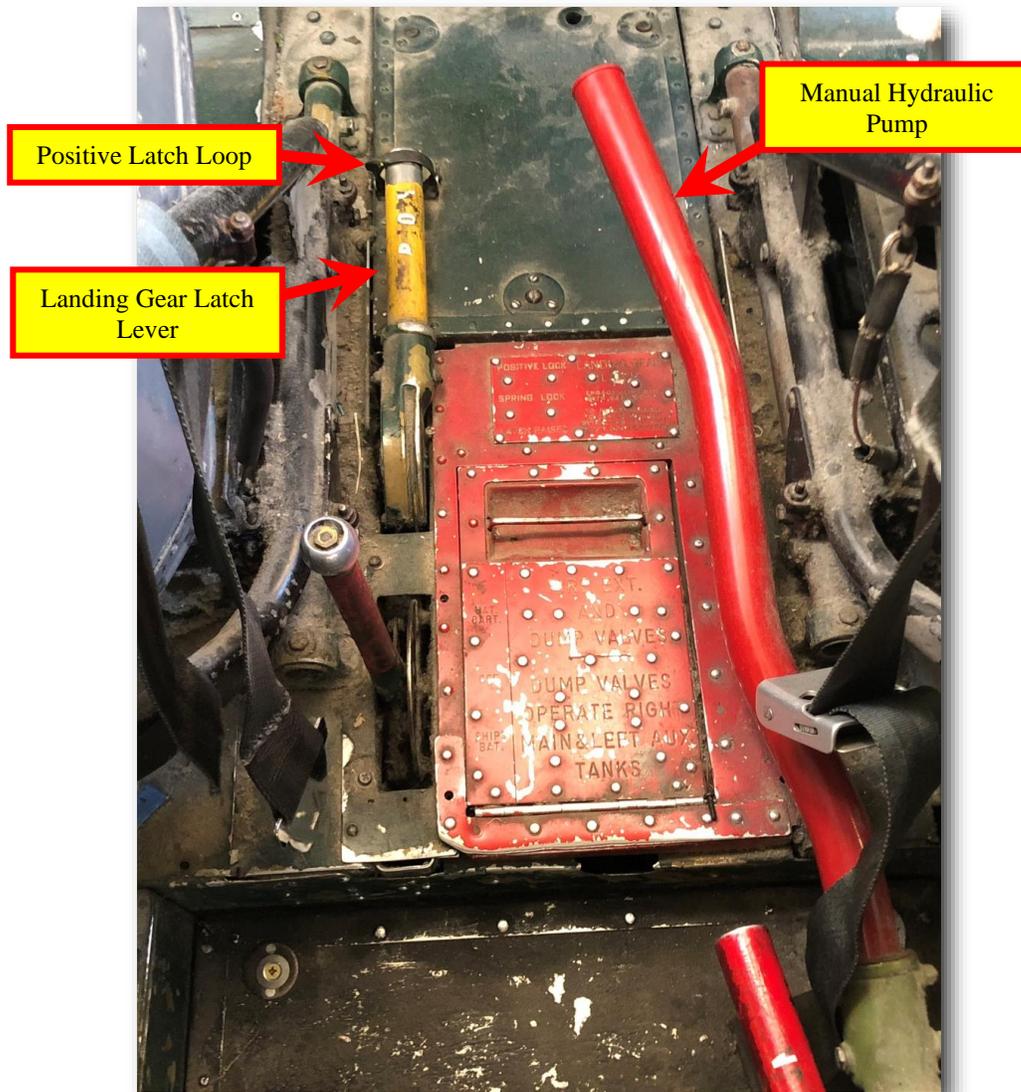
The landing gear latch (“spade”) was controlled by a short lever on the floor of the cockpit, just to the right of the pilot’s seat. Pulling up on the handle pulled the spade out of its slot, releasing the gear. When the landing gear latch was in the full down “engaged” or “positive latch” position, a small metal loop swung up over the handle to prevent it being lifted. Thus the security of the landing gear remaining extended fell to a small loop over the end of a lever. No solenoids, no limit switches, no software. This handle also controlled a pawl on the landing gear hydraulic valve handle which controlled the ability to move this handle to the “retract” position. The landing gear latch handle had three positions:

1. Full down (Positive Latch). In this position, the spades were engaged, preventing the landing gear from retracting. The pawl on the landing gear hydraulic valve handle was engaged, preventing the handle from being moved up to the “retract” position.
2. Halfway up (Spring Latch). In this position, the spades were retracted against the springs. The pawl on the landing gear hydraulic valve handle was engaged, preventing the handle from being moved up to the “retract” position.
3. Full up. In this position, the spades were retracted against the springs. The pawl on the landing gear hydraulic valve handle was retracted, allowing the handle to be moved up to the “retract” position.

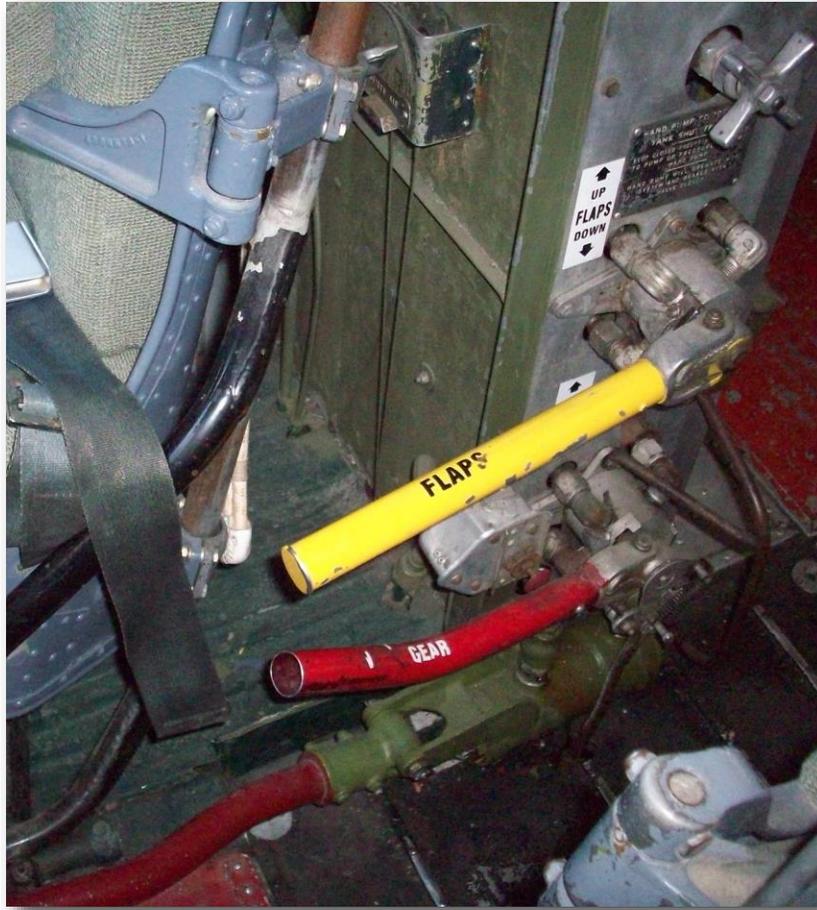
The landing gear hydraulic valve handle was directly attached to a hydraulic valve which directed hydraulic fluid under pressure to either end of the hydraulic actuator that moved the landing gear. Pulling up on the handle raised the gear. Pushing down on the handle lowered the gear. This handle was normally operated by the copilot, but could be operated by the pilot. Pushing down on the handle was a long stretch from the pilot seat. Returning the handle to the neutral position closed the valve and trapped hydraulic pressure in the lines.
