The Trailing Edge

June 2023

A Near Tale of Woe, or “The Fracture Mechanic Strikes Again!”

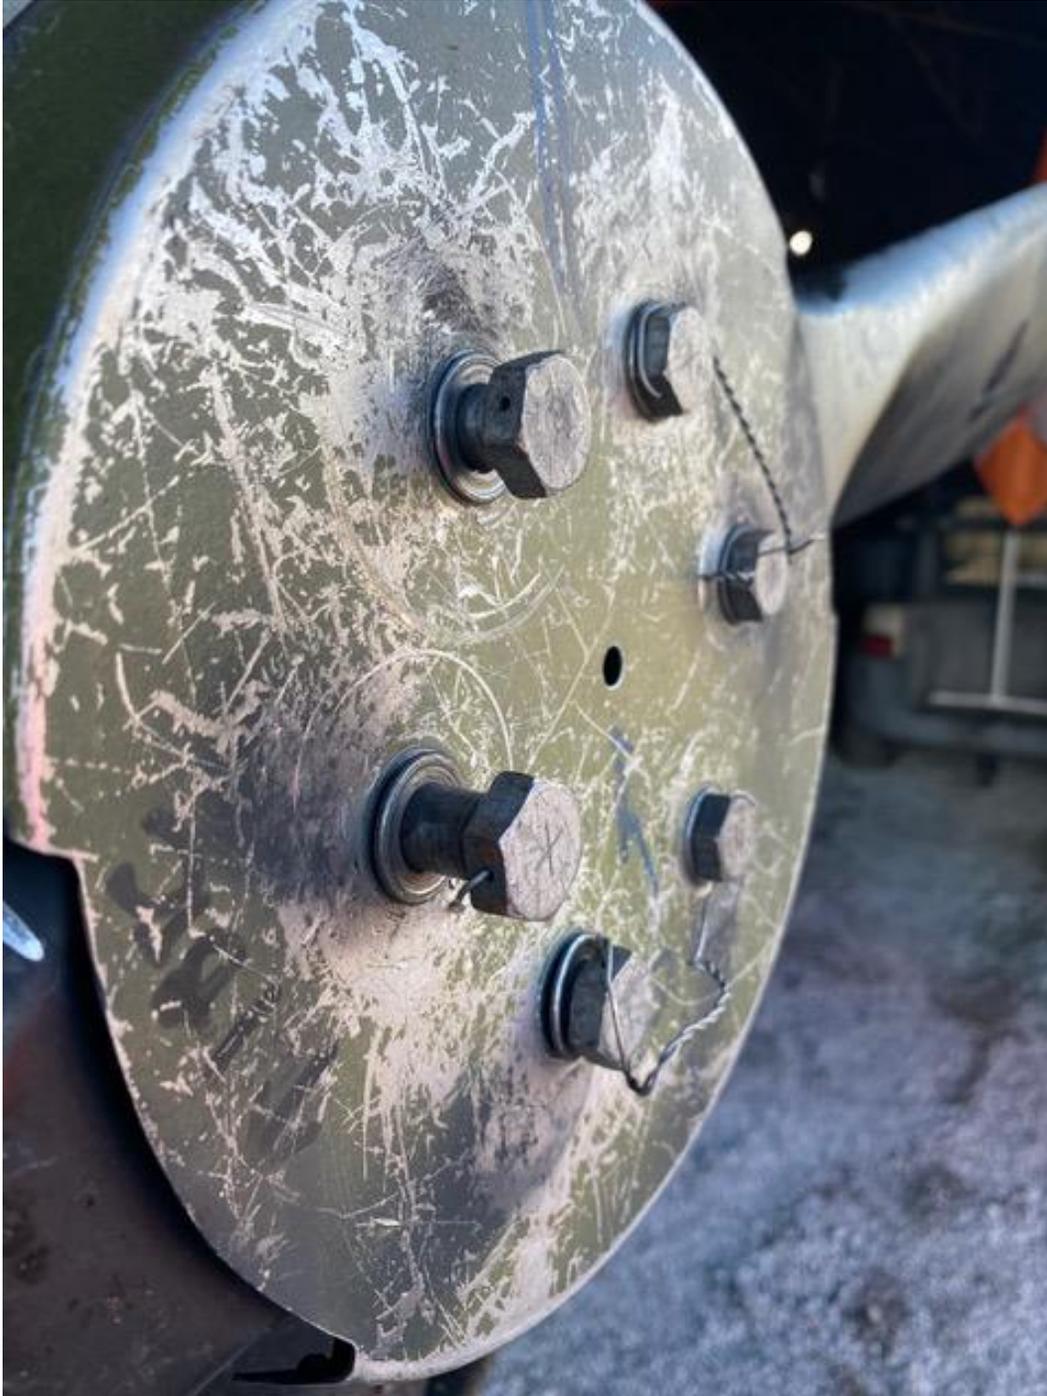
Spinner plate on front of the propeller hub

To anybody familiar with aviation maintenance procedures, this image will usually induce an immediate “oh s..t!” exclamation. You’ll notice that none of the safety wire is intact. From this photo, it appears the safety wire on the bolts at 2 and 6 o’clock are attached backwards and are applying loosening torque to their bolts. Two of the bolts appeared to be completely out of the threads and were essentially only still there because the spinner wouldn’t let them out all the way. One other bolt had backed out partially and was removed just using finger pressure, and the three final bolts were essentially the only ones holding the prop down to the flange. They suspect that the round scrape marks around the two broken bolts were where the safety wire scored the spinner front plate as the bolts spun. When the three loose bolts were removed, it was discovered that two of them had sheared completely.

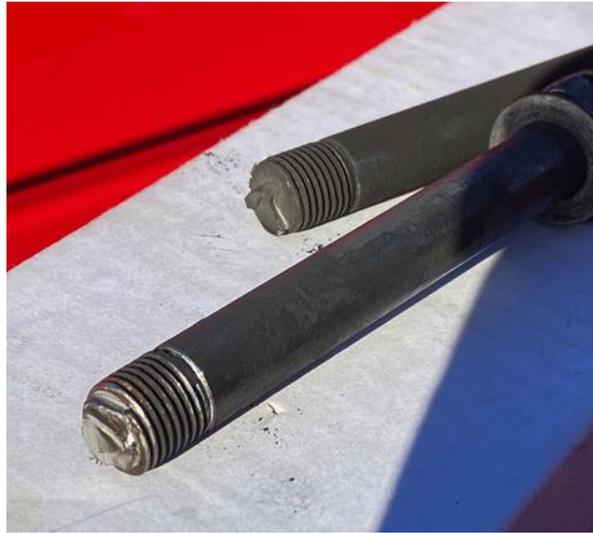
Fractured propeller bolts

These bolts didn't just "back out", they appeared to have failed in tension. The ends of these bolts showed signs of classic metal fatigue ending in complete failure and the crankshaft propeller hub bushings still had the ends of the bolts in them. Here's what the bushing/nuts at the front of the propeller hub looked like:

Prop bolts are definitely in a “high stress” part of the engine. Every time a bolt is torqued, it “stretches” just a teeny bit, and the thinnest part of the bolt is in the threads which have sharp corners. This poor girl’s prop bolts had been torqued (maybe even overtorqued) multiple times, and over the decade plus period of this story, a crack started on one of them, and it continued to grow.

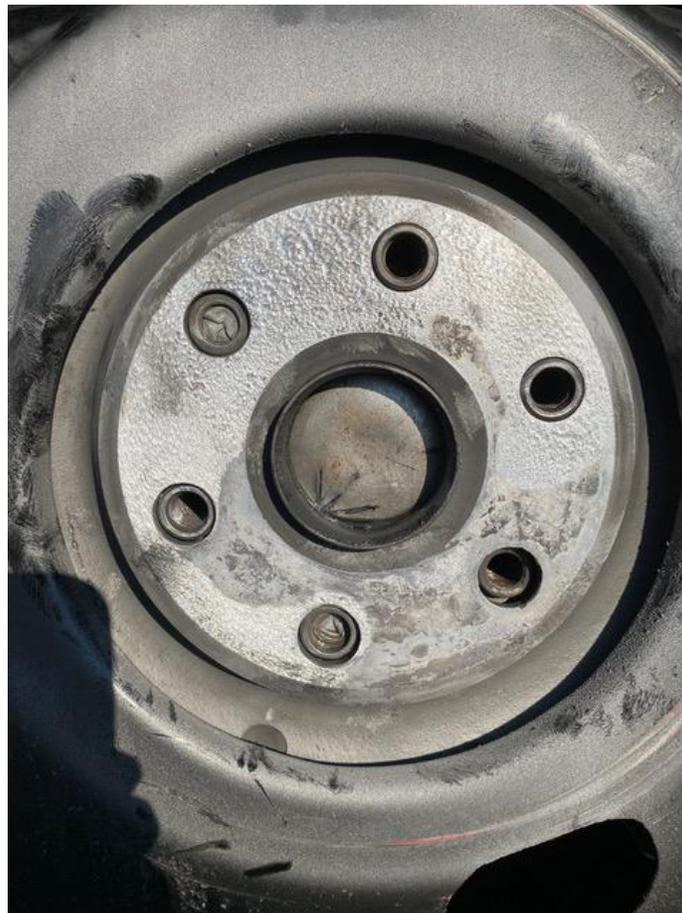
Front view of crankshaft propeller hub.

Notice the two bushings with bolts still in them in the above photo in the 6:30 and 10:30 position. The bolt at 8:30 had backed itself completely out of its bushing. The bolts at 12:30, 2:30, and 4:30 were the only ones holding the propeller on.

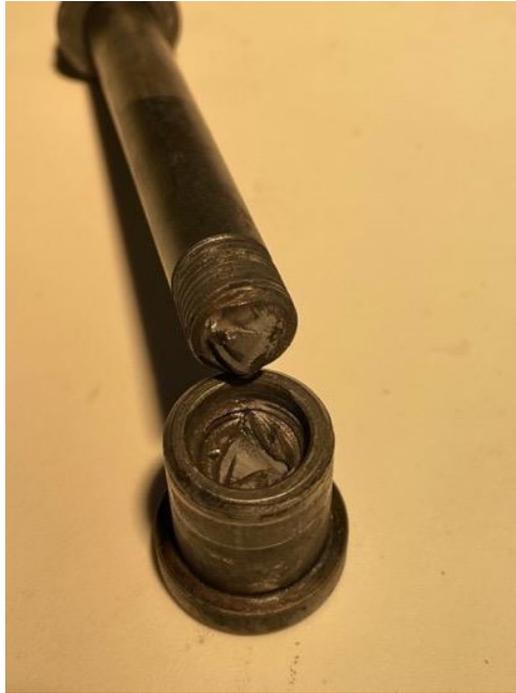
Fractured bolt and companion bushing/nut.

As you could imagine, loose bolts are bad enough, but failed or disconnected bolts are really bad news as they no longer provide any support in the direction (tension in this case) they are supposed to support. This allowed vibration between metal components and assemblies of different hardness. Although all the bolts and bushing/nuts are steel, the propeller is aluminum, and aluminum is significantly softer than steel. THIS is what the back of the fixed pitch propeller looked like:

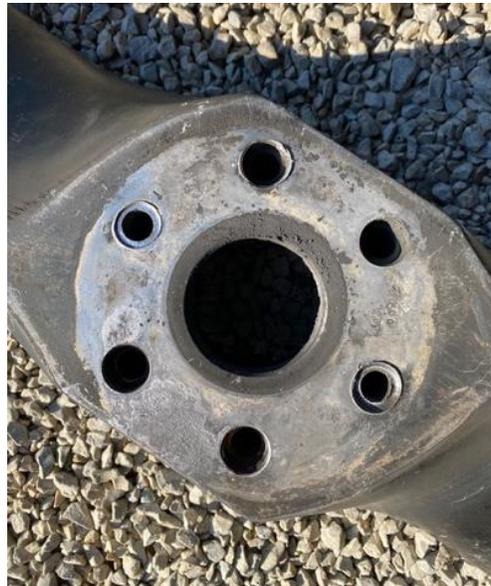
Damaged propeller hub

So the failure of these propeller bolts resulted in all kinds of additional motions by both the bolts and the prop, resulting in the destruction of the propeller hub (thus making the prop unusable).

With this much damage and vibration occurring on the front of a crankshaft, the next question is whether the crank or bearings are damaged. The basic test for this problem was to mount a dial indicator to measure the “roundness” of the hub and crank to see if it is in limits. In this case, the “old girl” received even more good news, as the “runout” of her hub and crankshaft were within limits.

As we also noted before, the “old girl” was complaining. A destroyed fixed pitch prop, bolts, and bushings easily costs several thousands of dollars of repair. Damaged journal bearings, or crankshaft damage is tens of thousands of dollars at a minimum. She’s still awaiting parts and the final surgery to put her back together, but due to the careful gaze of one pilot, and the love of her co-owners, the club is looking forward to having her fulfill her flying missions again.
