# *The Trailing Edge*

## **Battery? What Battery? My Indoctrination as an Experimental Avionics Hardware Technician**

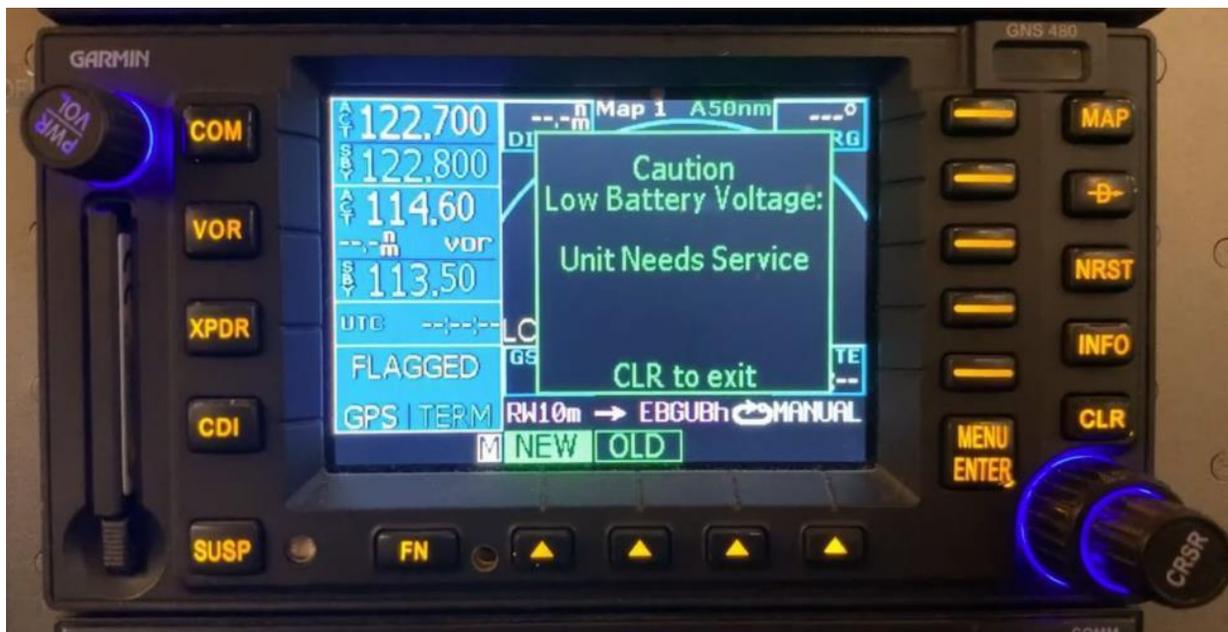
On startup on Saturday, 19 January 2026, the GNS 480 started up with the dreaded message.

This looks like the message that Stormy was talking about. Apparently, there is a battery in this box, and it is no longer happy. I guess I shouldn't be too upset—the last record I have of this box being touched by Garmin, possibly to install the WAAS upgrade, was in 2010. That means the battery lasted for about 15 years compared to the projected 10 years, so I guess I got my money's worth.

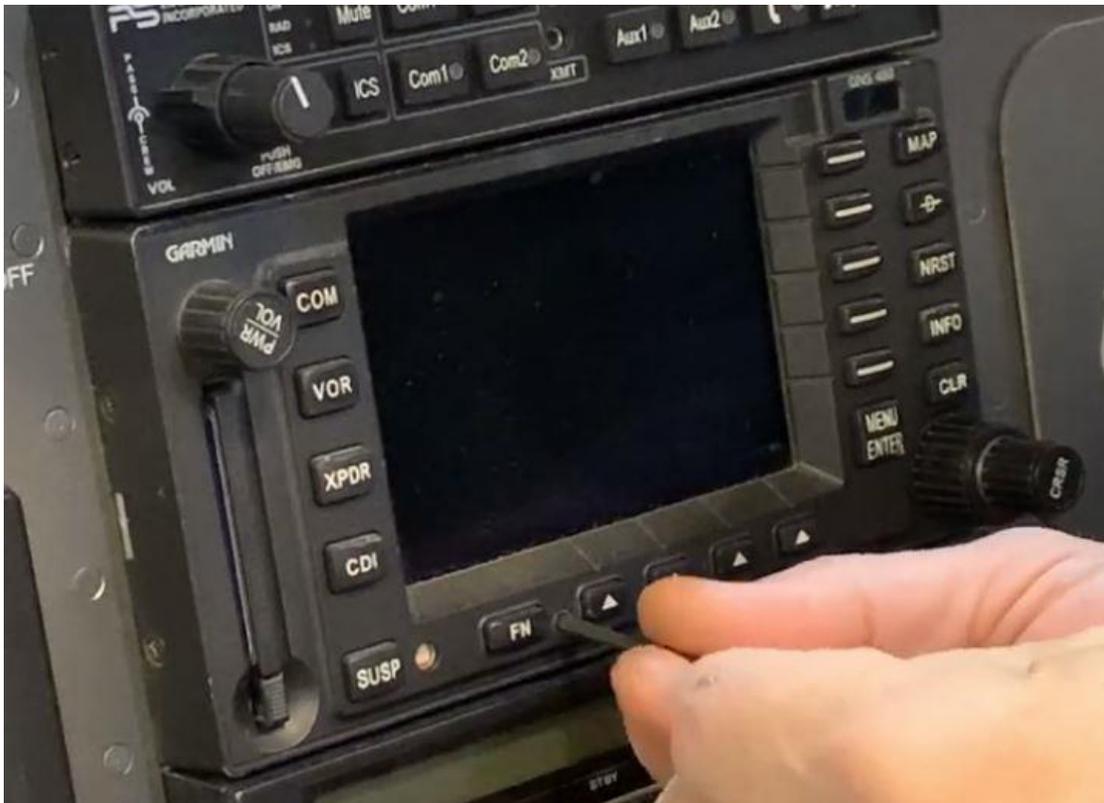
The first step was to remove the GNS 480 from the airplane. Most modern avionics are mounted in a matching tray, which allows easy removal of the box. Generally, the first step is to insert a hex wrench into a small hole in the front of the box and turn it counterclockwise.

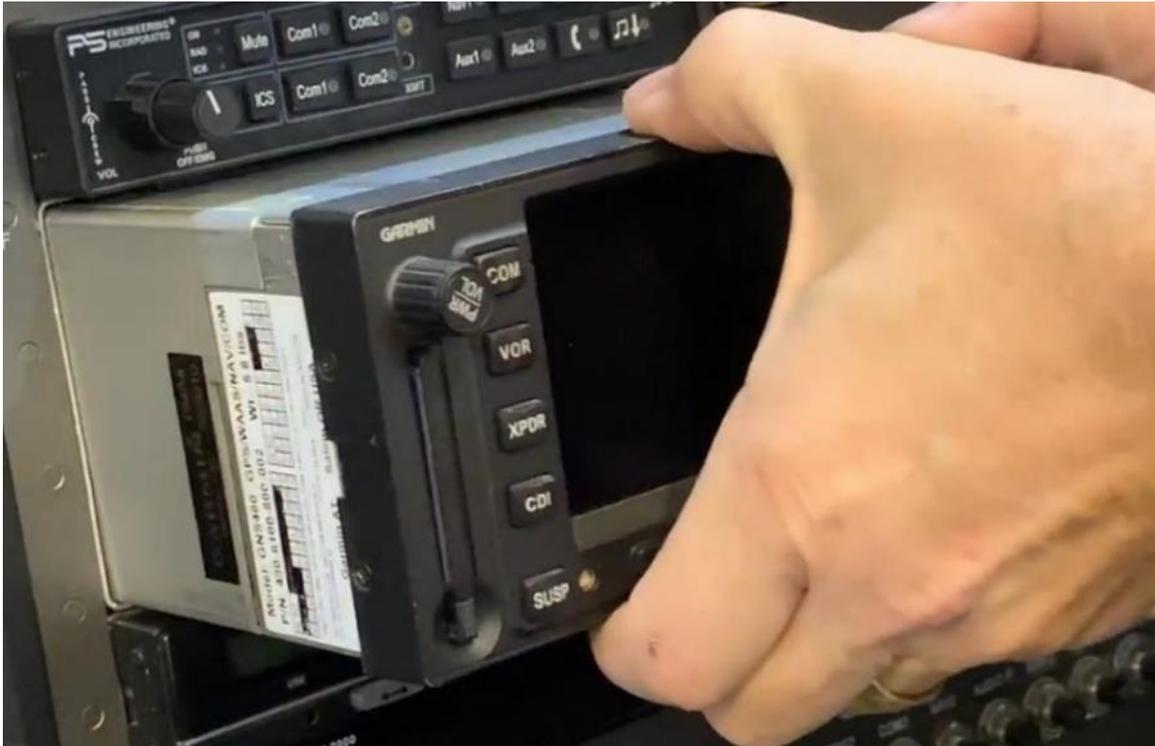
Continue to turn the wrench as the box slowly moves toward you out of the tray about 3/8 inch, when the wrench will stop turning. At this point, the box is released. Grab the sides of the box and pull it out of the tray toward you.

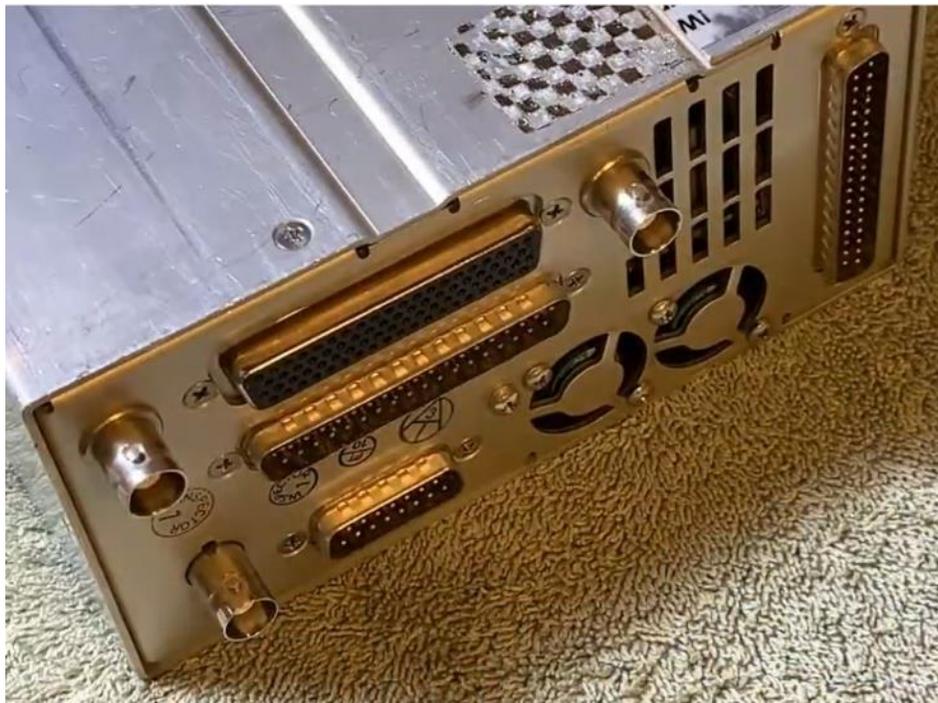
The connectors between the box and the tray are all on the backplane of the box. Pushing the box into the tray pushes the connectors into the corresponding connectors on the tray.

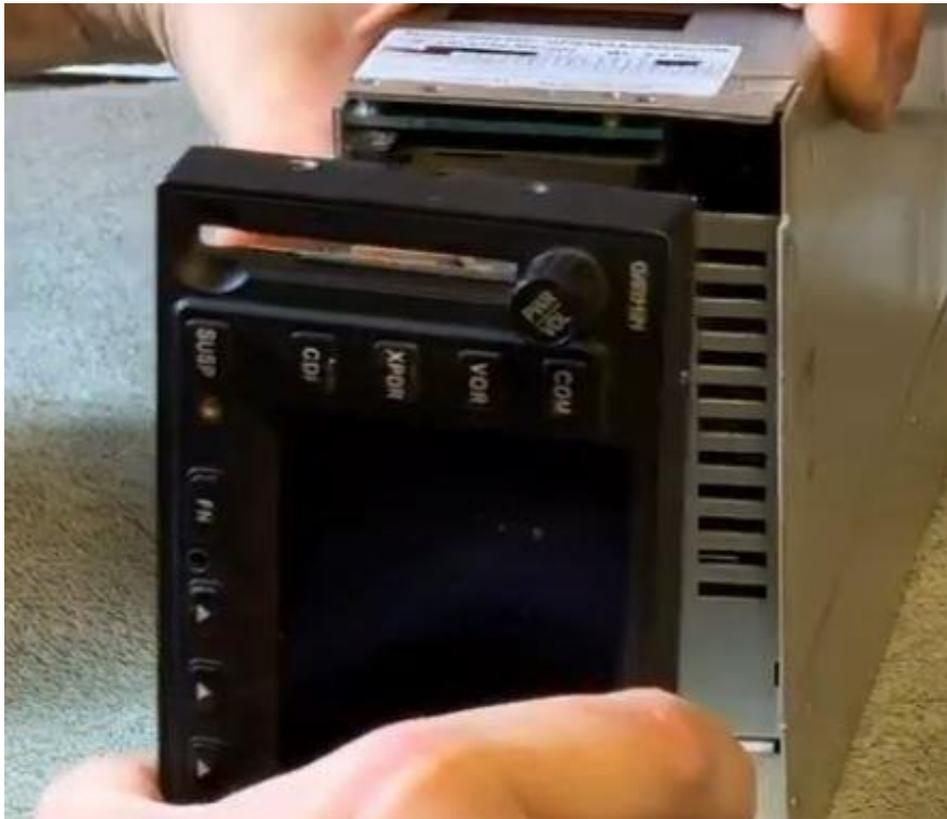
To open the GNS 480, first remove the screws around the faceplate. The faceplate pulls straight off the front of the box.

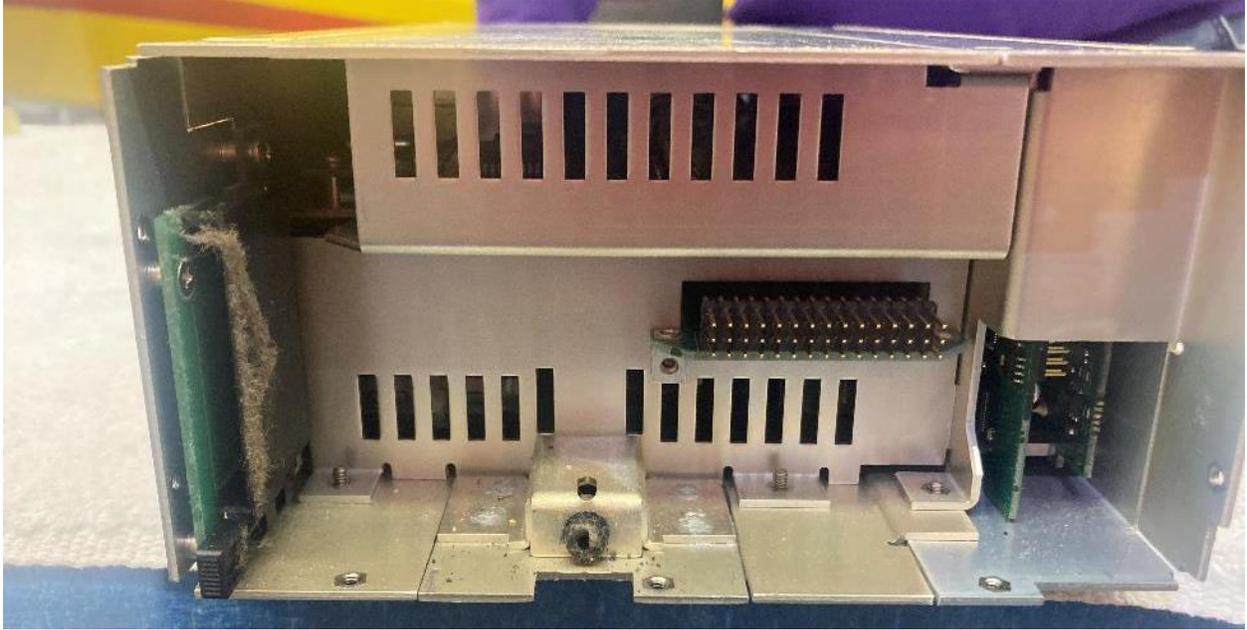
The faceplate is connected to the rest of the unit through one large, multi-pin connector as shown here on the back of the faceplate.

(nice dust on the Compact Flash data card holder)

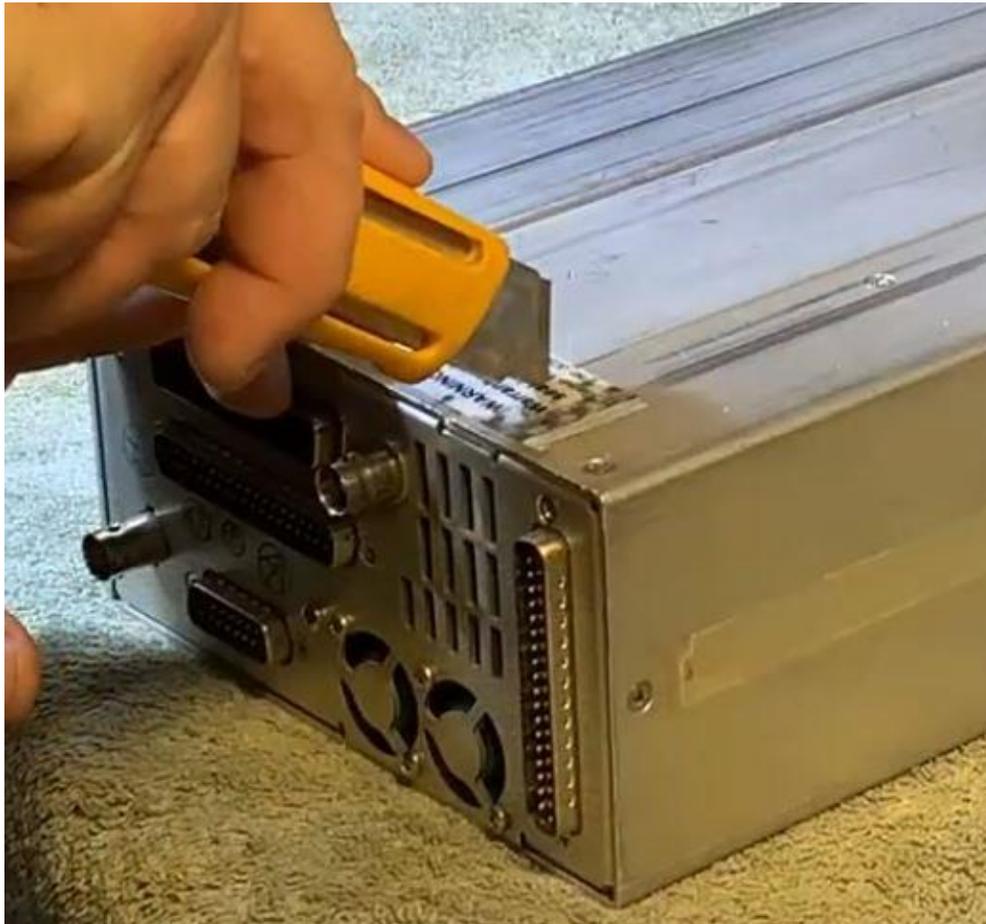
On the box is a label with the ominous warning that if this seal is broken your warranty will be invalidated. Since Garmin stopped maintenance support on this unit over 6.5 years ago, it really doesn't matter anymore if the seal is broken. Cut with a knife to separate the two box covers.

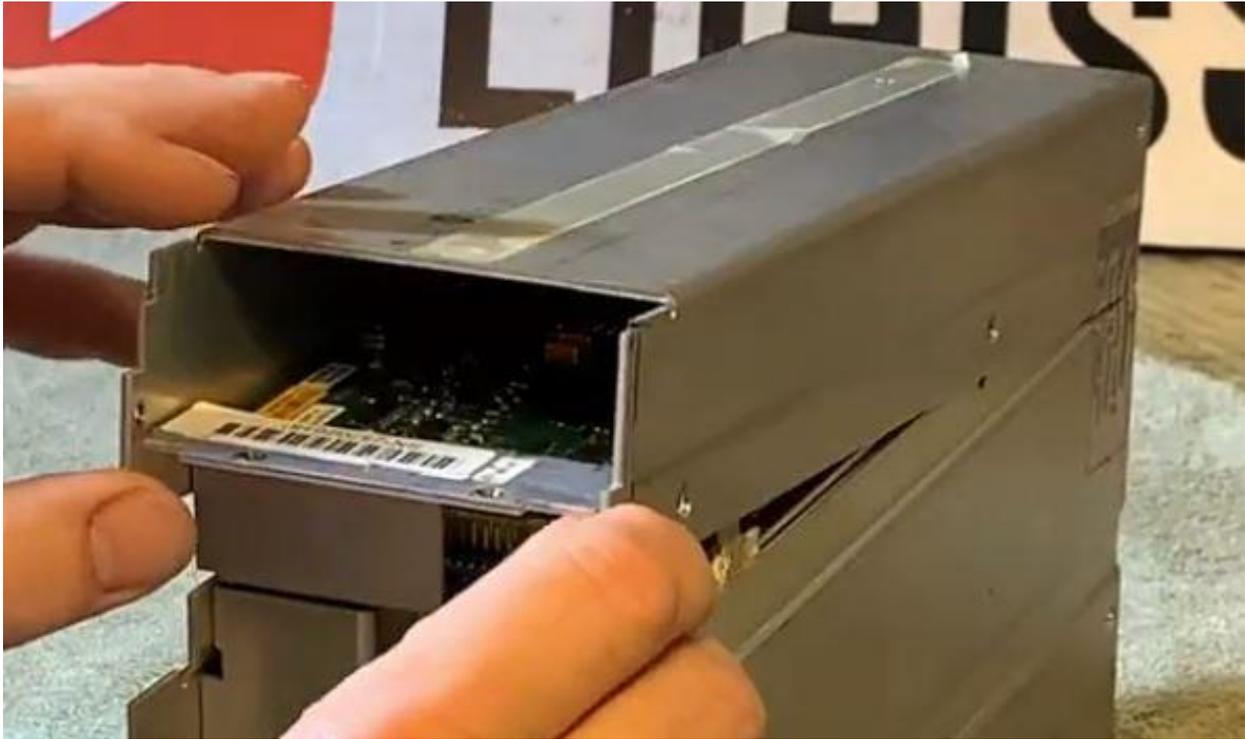
Remove the screws from the smaller box cover and remove the cover. This one has to come off first to let you take off the cover that is covering what you need to get to.

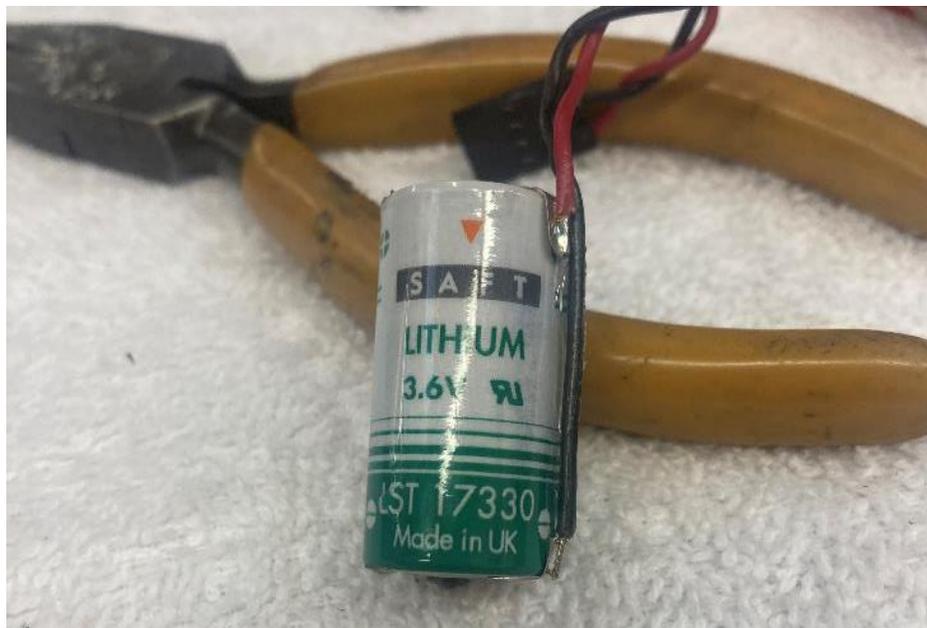
The battery as installed is wrapped in what appears to be some sort of heat shrink plastic. After cutting the plastic off, we see that the battery is a 3.6 volt lithium battery of the type 17330. This battery was labeled LST 17330, but the replacements I found on Amazon were listed as LS 17330. I can't confirm it, but the "T" may refer to this battery having tabs welded to the terminals for easy wire connections.

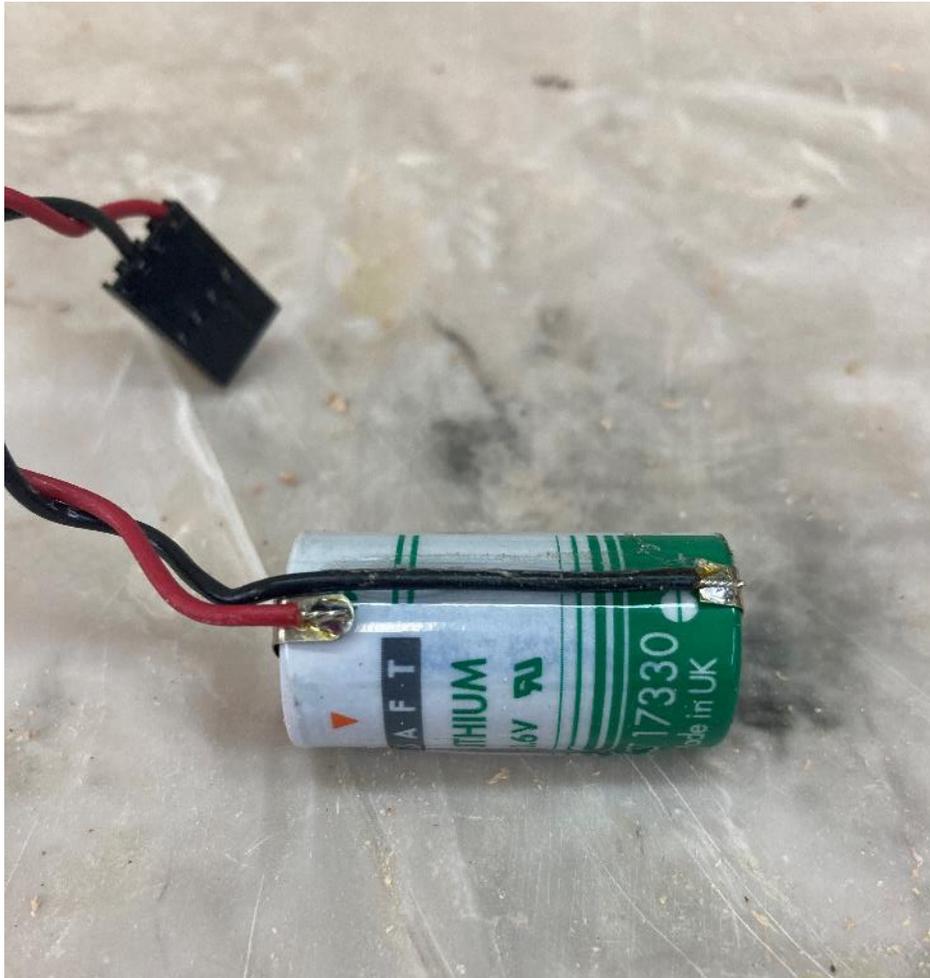
As we see here, the battery as installed by Garmin has wires soldered to tabs welded to the battery terminals.

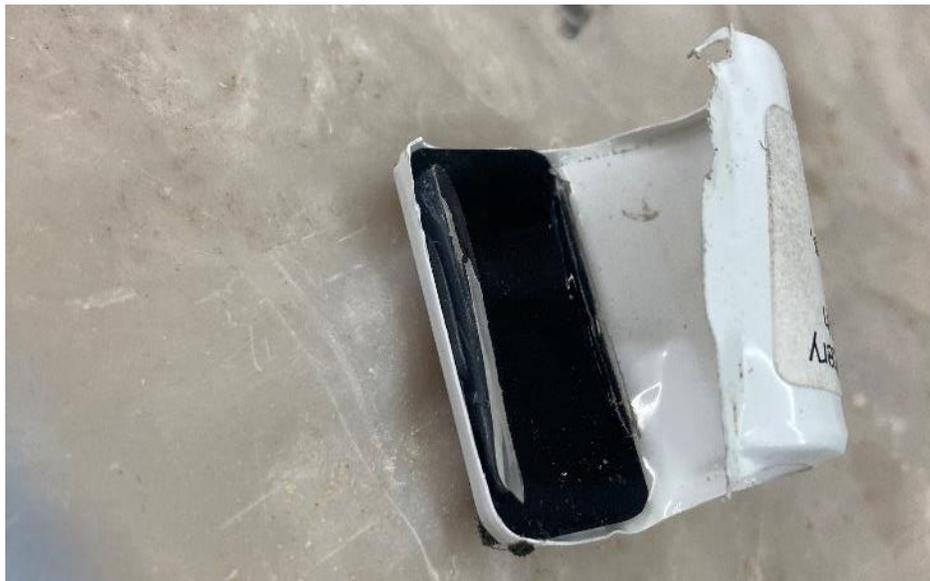
Cutting off the plastic encapsulating the battery shows a flat piece of plastic that creates a flat surface to attach the Velcro to.

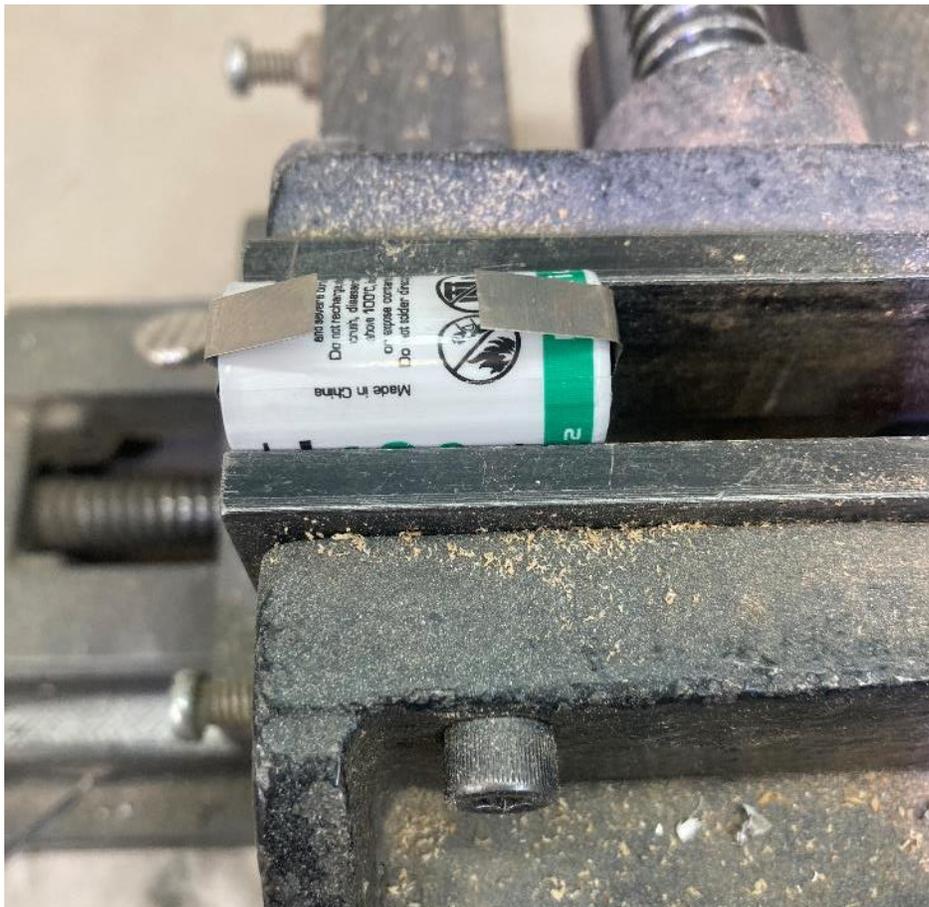
Here the battery is lightly clamped in my drill press cross vise to hold it in place while working on it.

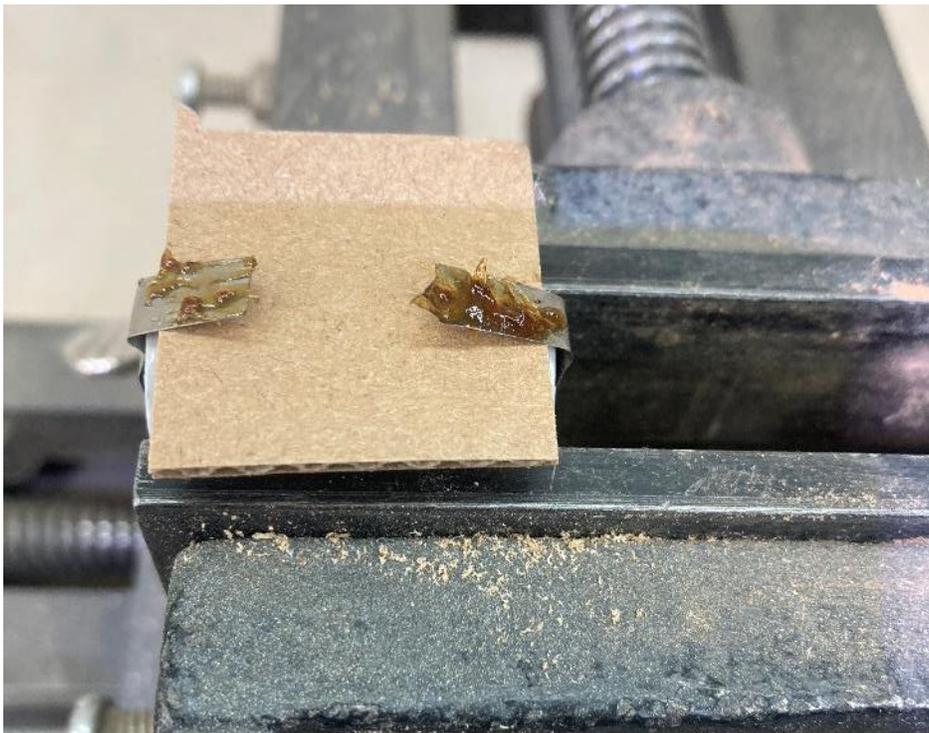
I smeared a healthy amount of the flux on the battery tabs.

I wondered if I needed to do anything different to solder to nickel tabs from what I did on copper. I found a helpful web page that I did not note the URL (Ref 3) which stated that nickel could be tricky to solder too. It recommended tinning the nickel tab with solder before trying to solder on the wire. It recommended using an acid flux on the nickel, but noted that it would attack the copper tip of the soldering gun, so the flux would need to be cleaned off immediately. However, it also mentioned a possible substitute of “Nokorode” flux. I just happened to have a tin of Nokorode flux which I probably bought back in the early ‘80s and is still half full.

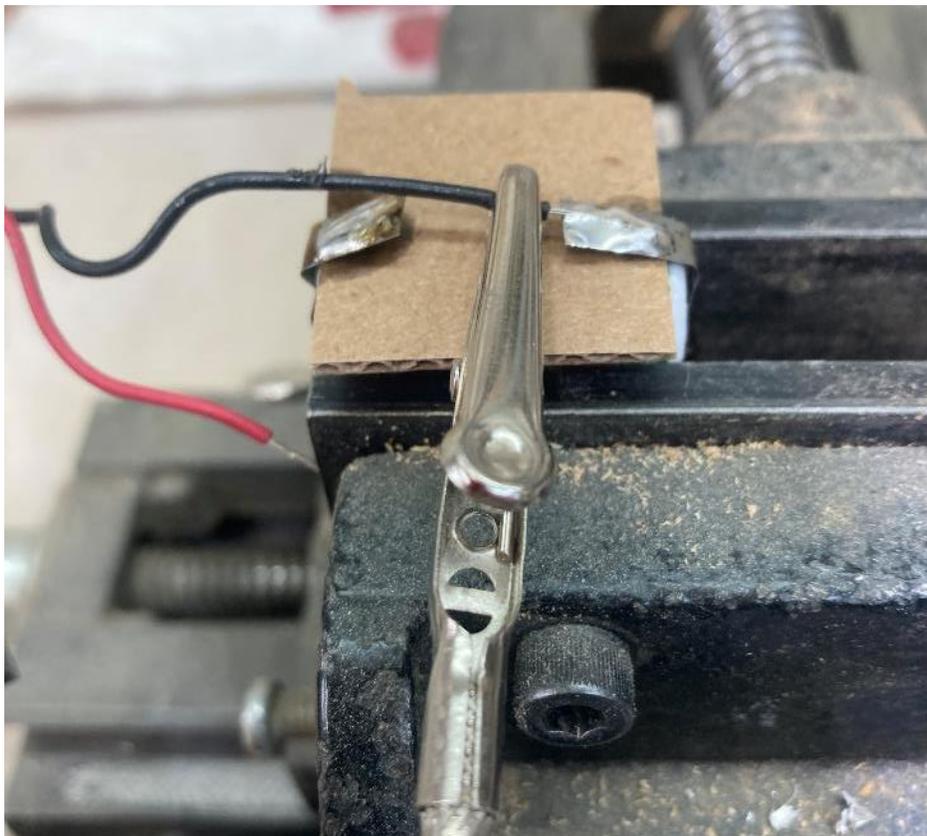
Using a helping hand alligator clip, I held the black wire over the negative terminal. I used the soldering gun to push the wire onto the tab. The solder melted and bonded the wire to the tab.

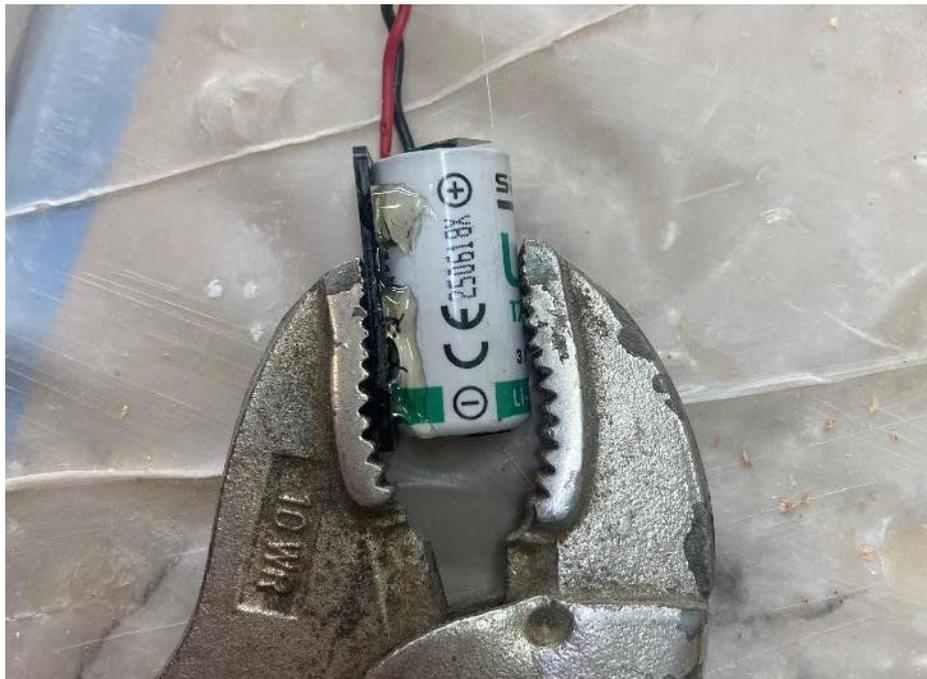
The flat plastic piece was held to the battery with lightly adjusted locking pliers and hot glued in place on both sides. It is important to get the flat plastic piece in the right position relative to the wires so that the wires come out without interfering with the battery box. I got it right the second time.

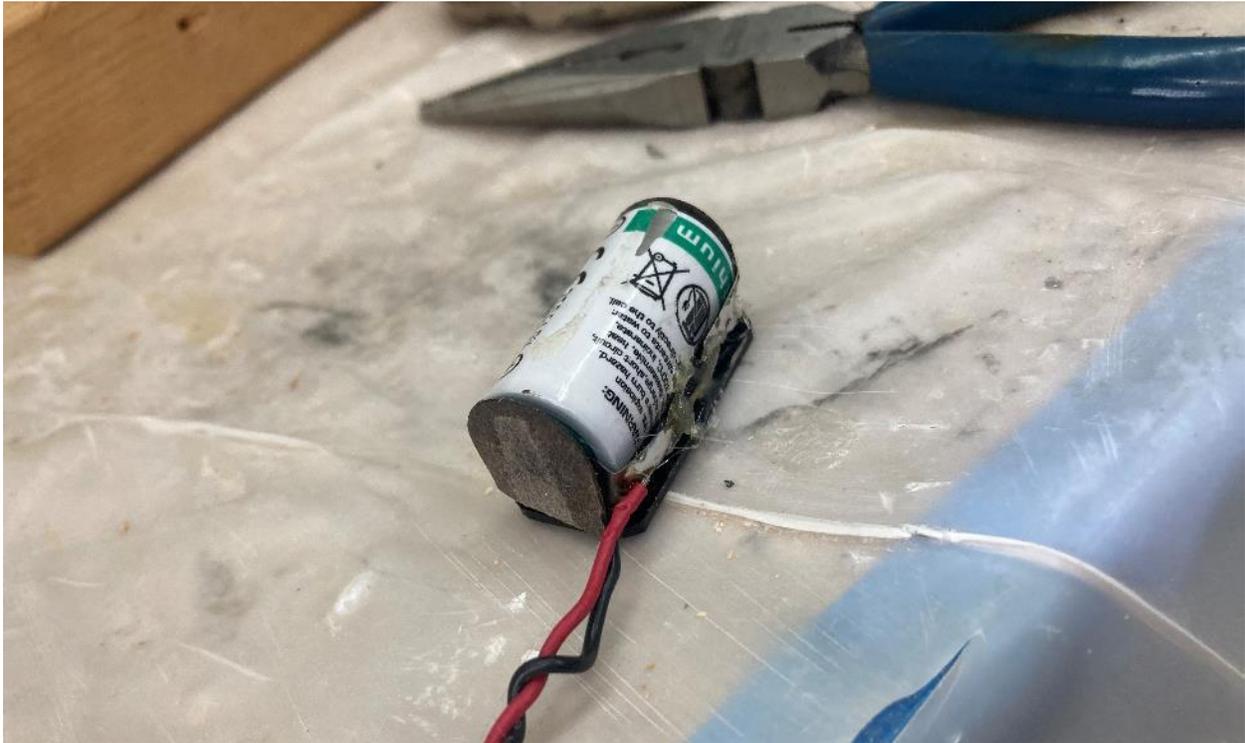
The battery removed from the GNS 480 was packaged with a piece of thin cardboard over each end of the battery to protect the terminals from short circuit. The cardboard pieces removed from the dead battery were tacked in place on the new battery with a drop of hot glue.

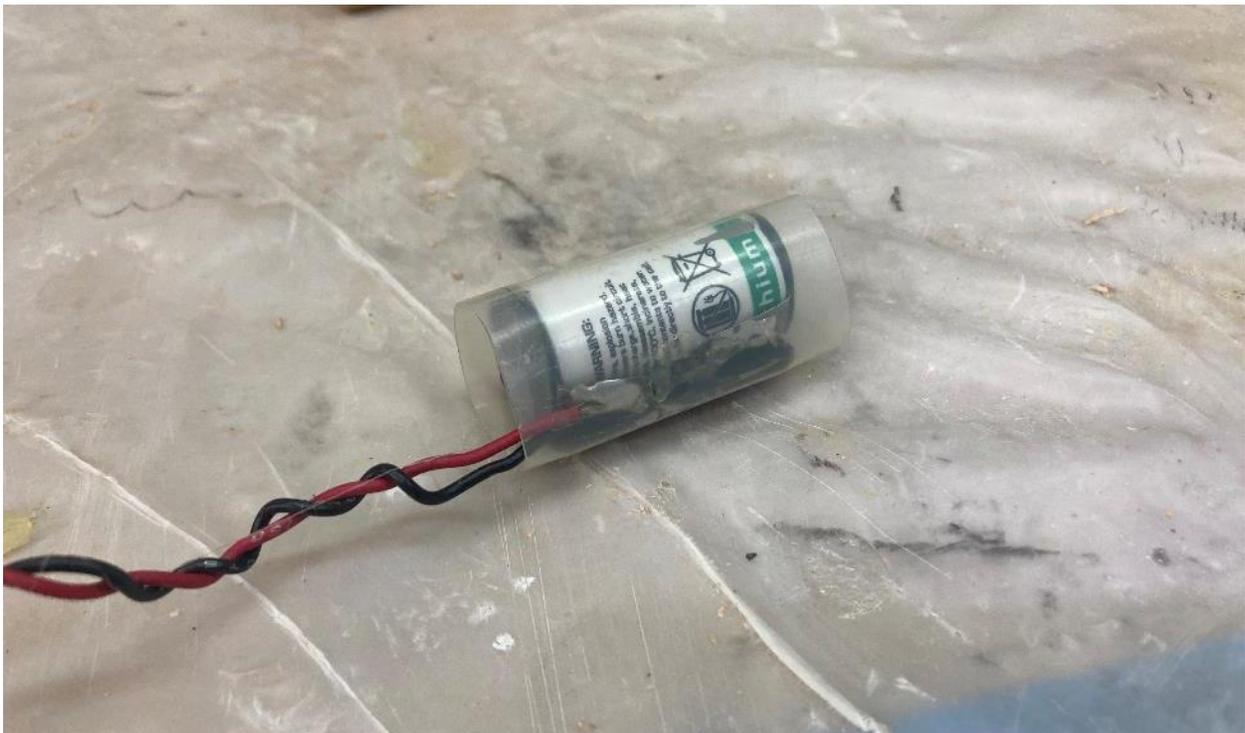
To finish the encapsulation, a piece of 3/4 inch heat shrink tubing (left over from making starting battery cables) was slipped over the battery assembly. It just barely fit.
