The Trailing Edge

June 2025

Bearhawk Alternator Field Replacement

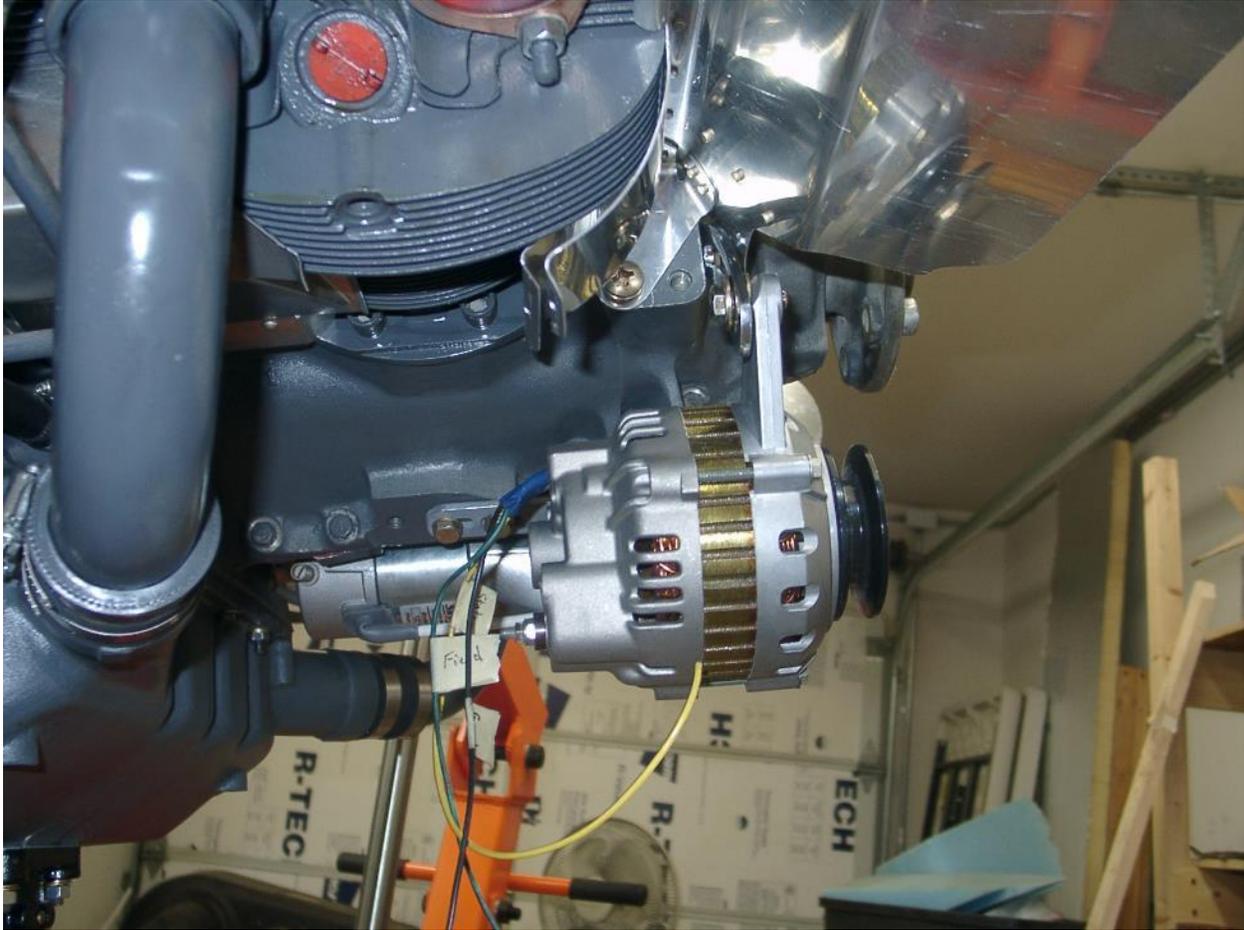
Side view of Mitsubishi alternator

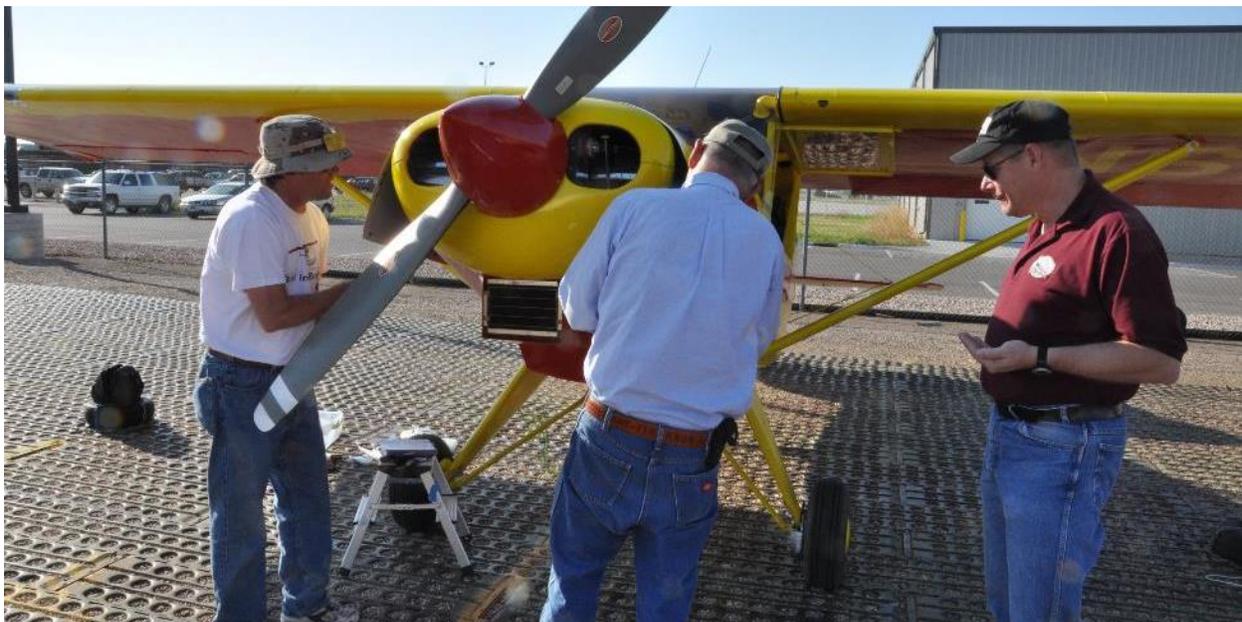
Jimmy Doolittle III and I work to remove screws and release the lower nose bowl. Stormy stands by as the official screw and parts holder

When we got the lower nose bowl removed, the problem was immediately obvious. Of the two brackets attaching the alternator to the engine block, the rear one had fatigue cracked itself into two separate pieces, thus allowing the alternator to move when I pushed on the belt. Additionally, the front mounting boss on the alternator had fatigue cracked itself free of the alternator casing. It's not clear which failure happened first, but a failure in either one would transfer the loads to the other one, causing the second failure. Apparently, this was in a very high vibration environment, because the alternator only had about 40 hours on it.

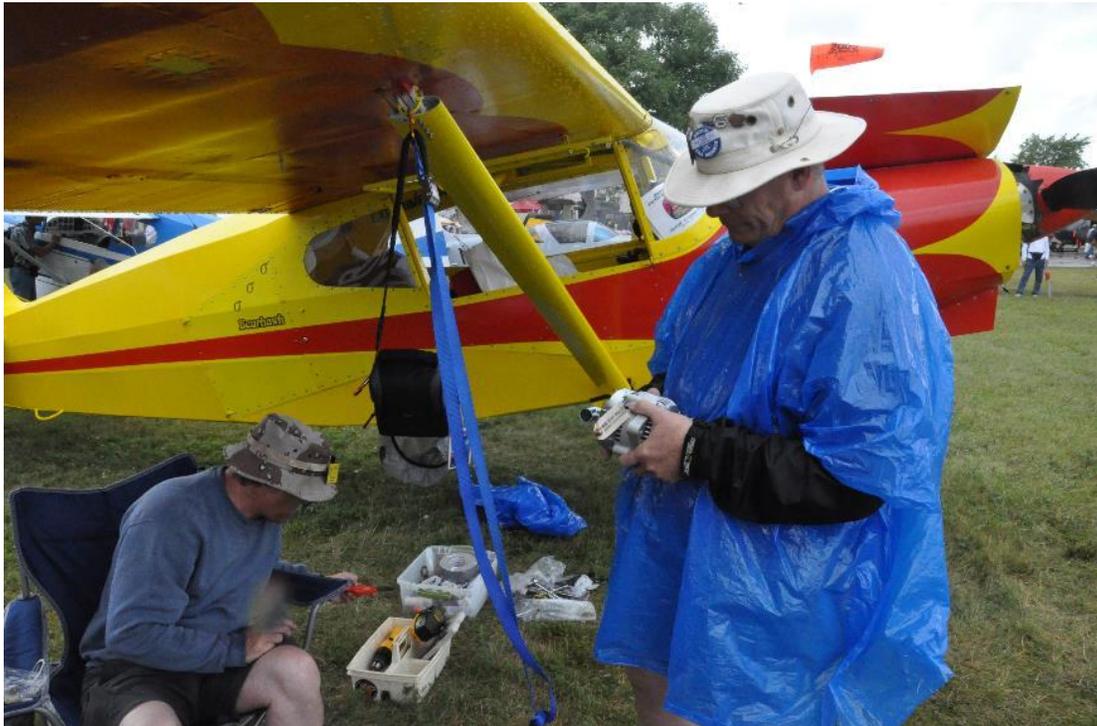
Here I am sitting under the rain protection of the wing working on the alternator installation. Sous-mechanic **Stormy** holds the new alternator while modeling the latest in stylish rain ponchos. I can't say much for myself, as I appear to be wearing shorts and a sweatshirt, a combination that I have often railed against as making no sense at all. Half of it says you think you're warm, and the other half says you think you are cold. I suspect what it really means is that I left the dorm that morning thinking temperatures would be hot, and when the rain started, I pulled a sweatshirt out of the airplane.

Also apparent is one of the benefits of a high wing airplane—the strut tie-down point is convenient for hanging your camera bag, keeping it off of the wet ground. Also shown are the efforts to keep the tools from disappearing into the grass.

Using the cordless drill, I drilled out the terminal on the output wire to a size that would fit over the stud on the alternator. Finally, I installed the alternator in its bracket. I found that the extra bit hanging off the alternator bracket was exactly the right length and shape to attach to the mystery boss on the starter motor that I had no idea why it was there. This gives even more rigidity to a mounting that had already shown itself to be prone to fatigue.

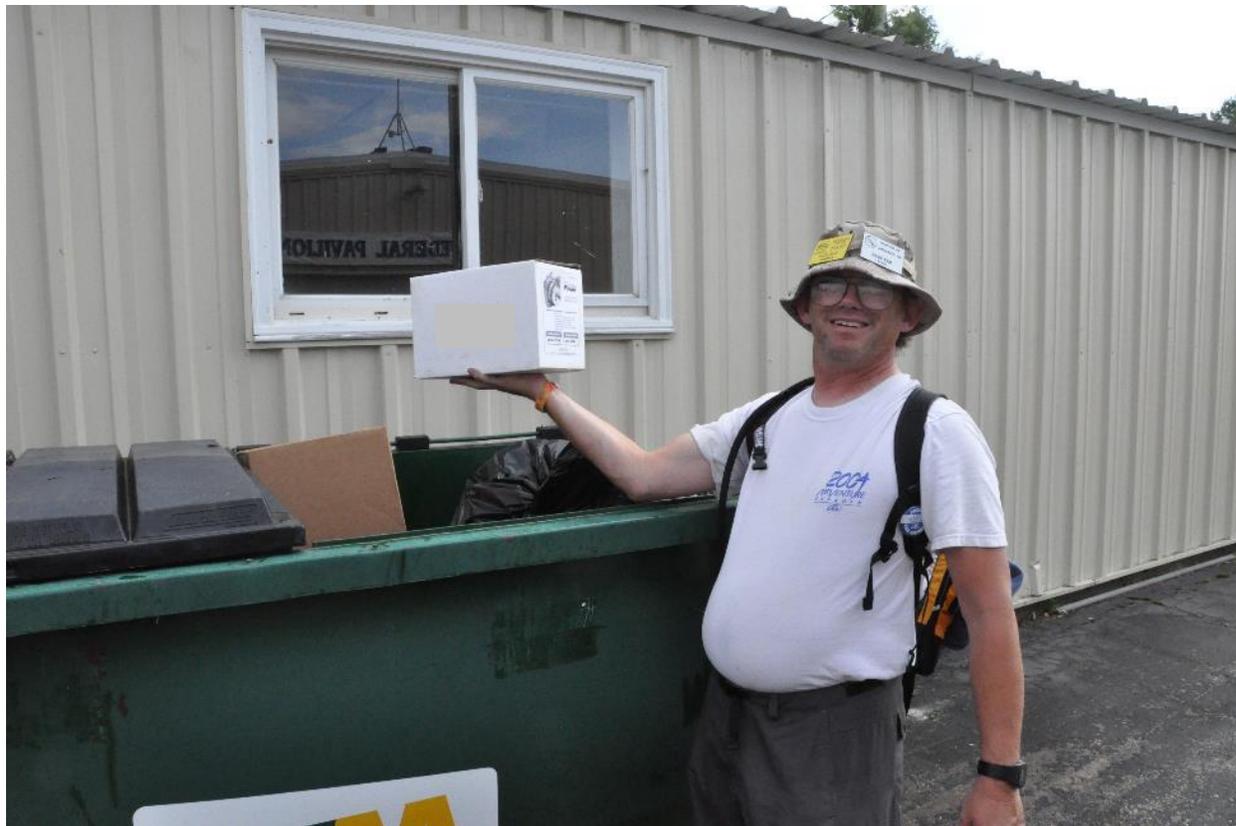
With the new alternator successfully installed, the nose bowl was reinstalled, making a complete airplane once again. The WRSK kit was reassembled and put back in the airplane. The borrowed tools were returned in the same condition as they were received. The old, busted alternator and associated bracketry were loaded in the box that the new alternator had come in. Immediately after this picture was snapped, the box fell into the Oshkosh dumpster, and I walked away from it without remorse.

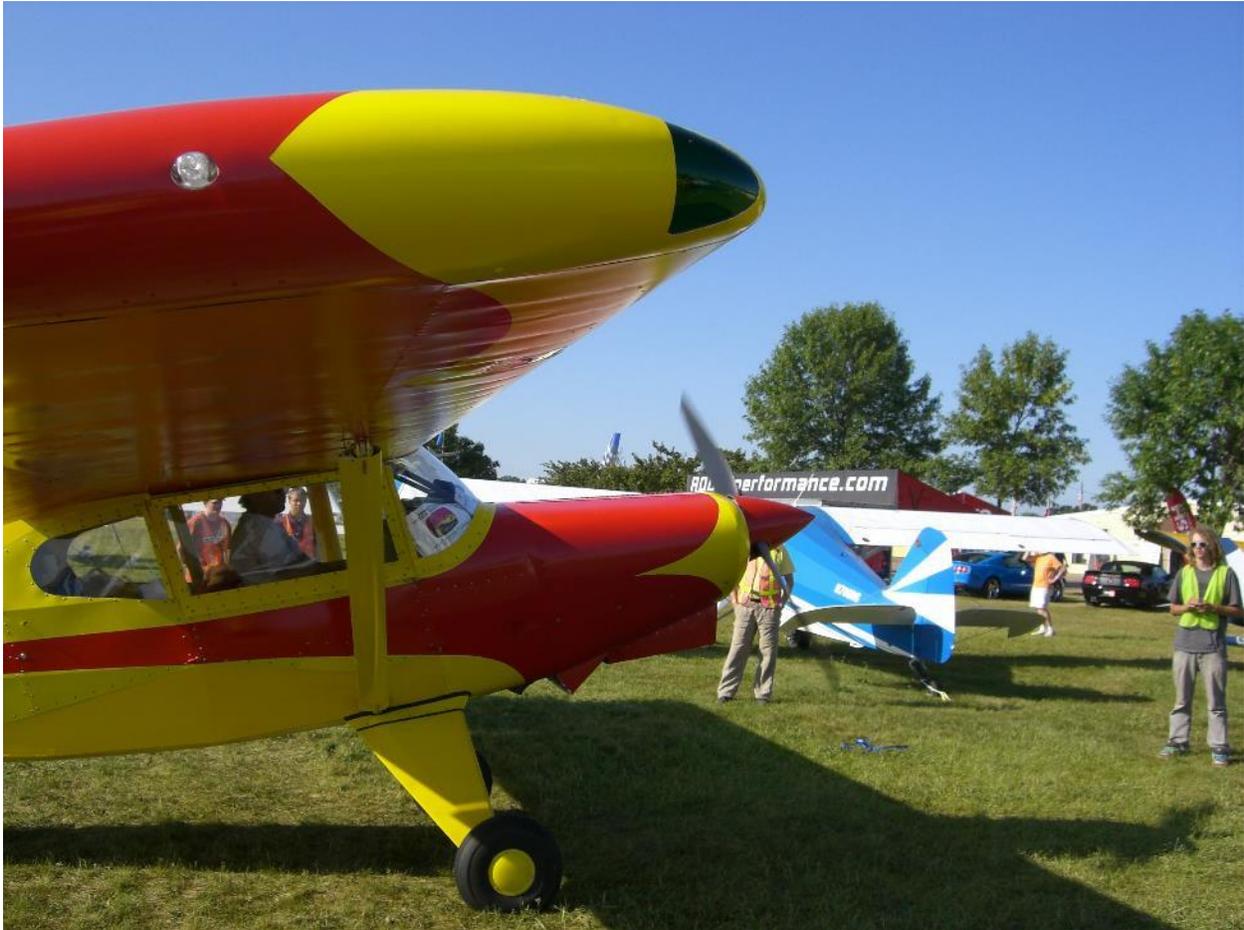
As briefed, I ran the engine start checklists. I hit the starter and the engine fired up. I looked at the EDM-900 engine instrument. When I had confirmed proper voltage and amperage, I shut the engine down. Total run time—less than 30 seconds. Confident that the new improved alternator would work properly for Sunday’s departure, we pushed the airplane back into its parking spot.
