The Trailing Edge

August 2023

Ford Trimotor Pax Qual

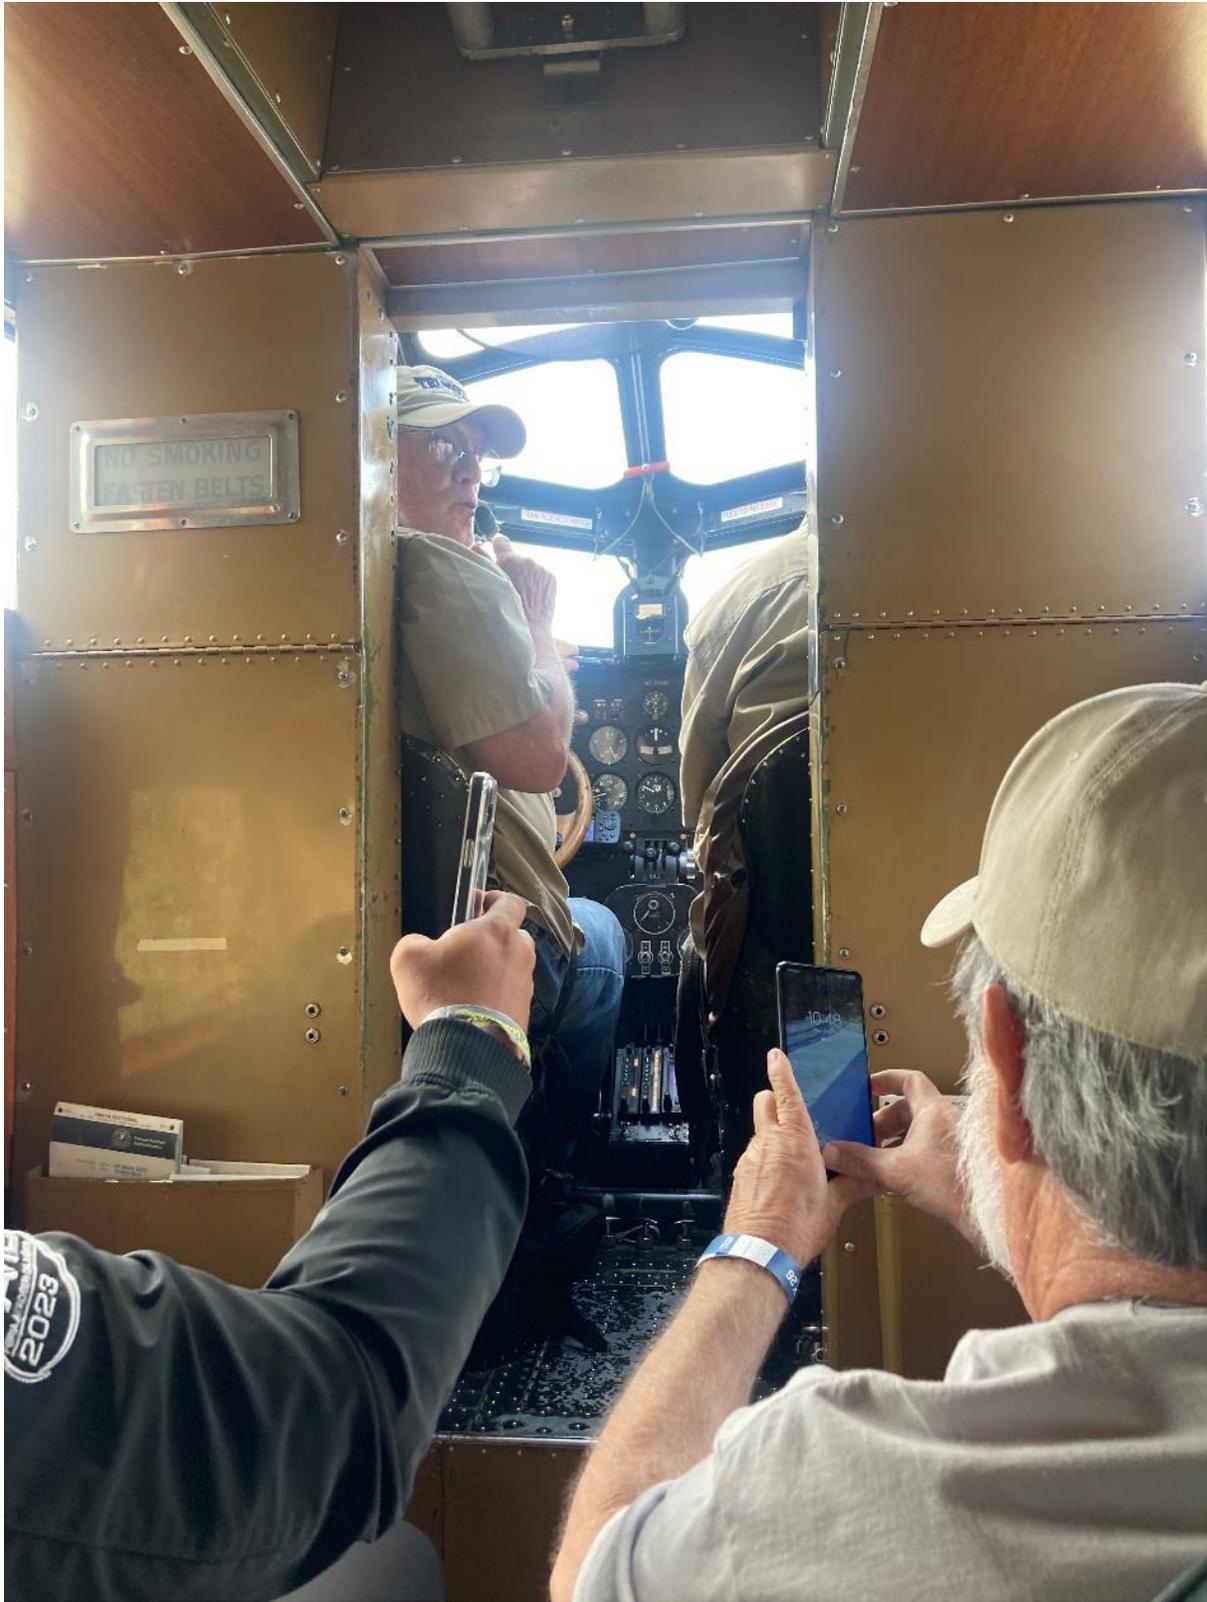
The cockpit. Visible are a magnetic compass, period correct intercom panel, clock, airspeed indicator, turn and bank indicator, #2 tachometer, altimeter, period correct Garmin GPS, throttles, magneto switches, and period correct radios and transponder

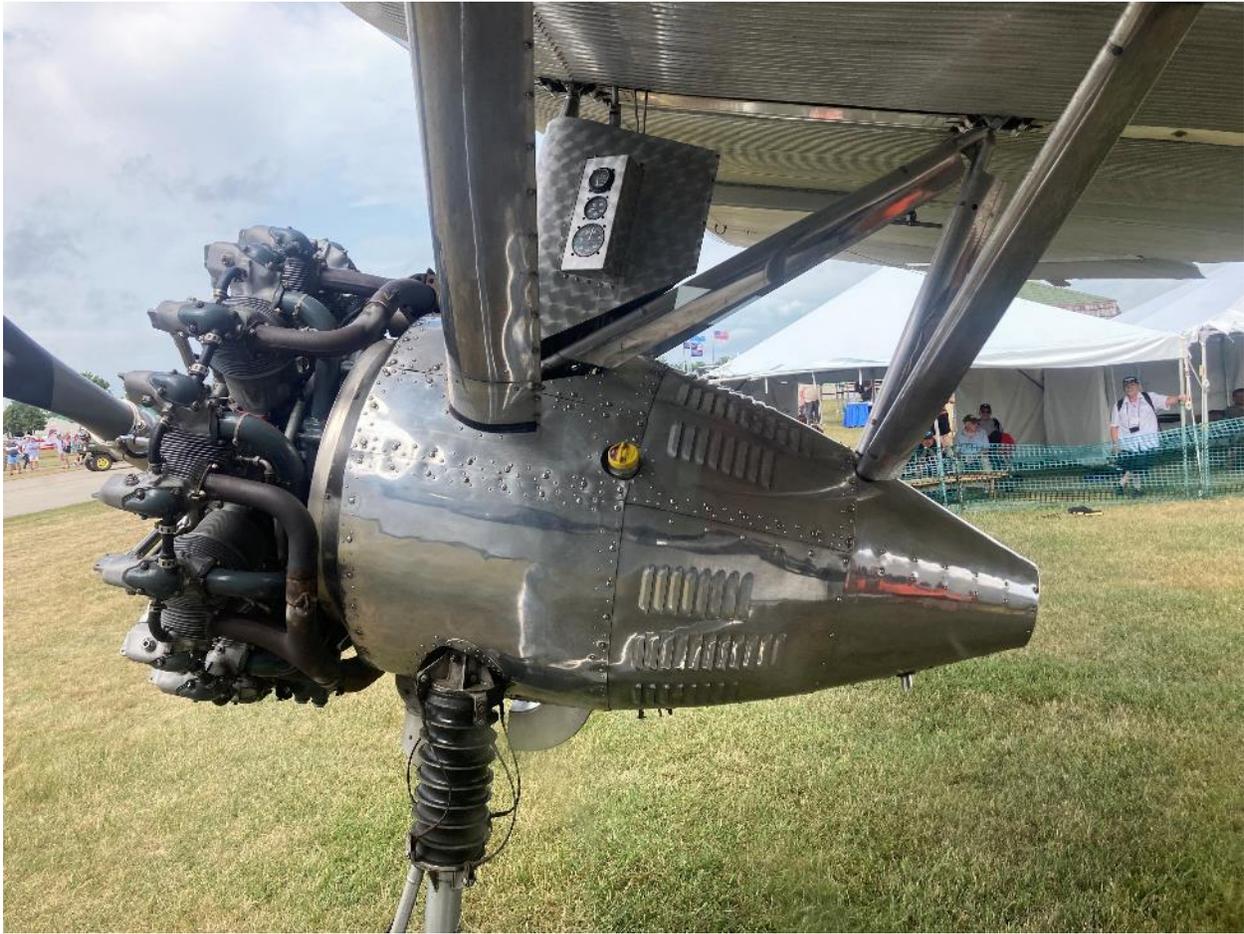
Engine instruments on the strut

The “gate agent” closed the cabin entrance door and the pilots started engine #3. For the wing engines, the engine instrumentation, to include oil temperature, oil pressure, and tachometer, was placed on a strut above the nacelle. The pilots look out the window to see how the engine is doing. I’m guessing it uses a mechanical tach, which means the drive cable is relatively short, compared to snaking it through the wing and into the cockpit. The engine instrumentation for #2 was in the cockpit.

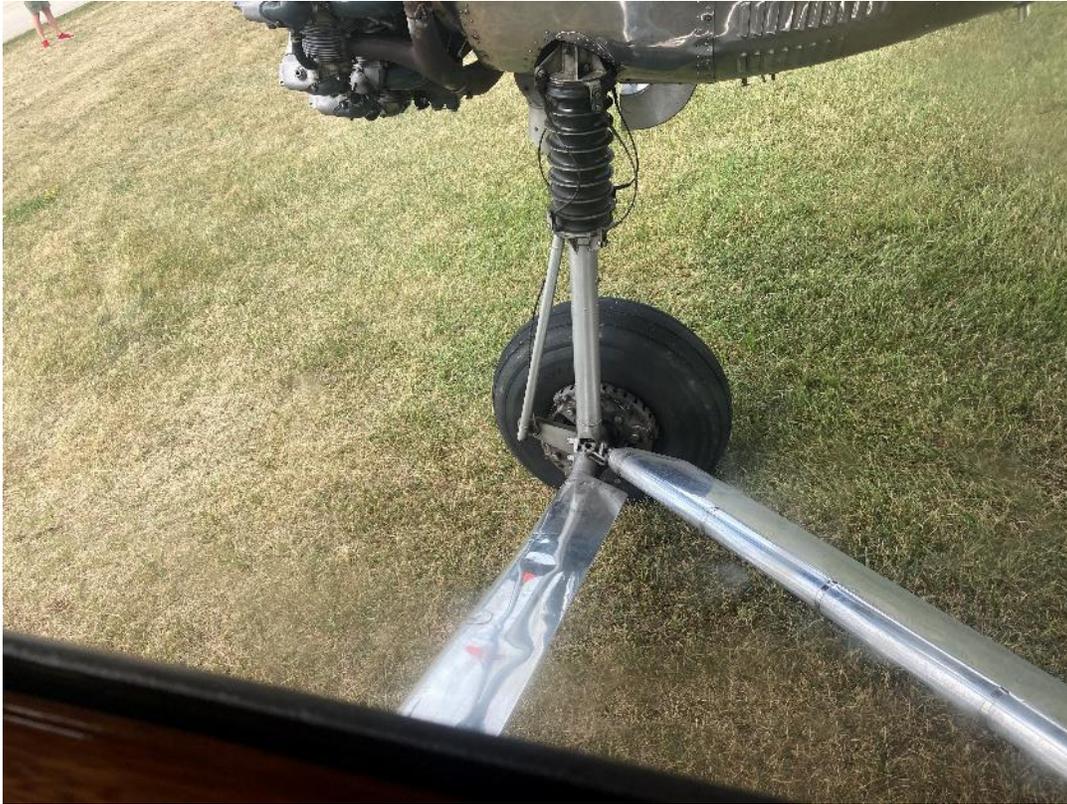
Landing Gear spring (in boot) compressed on the ground. Note loose cables.

Suspension on the main landing gear was a coil compression spring on the vertical strut under the engine nacelle. The coil spring was covered in a rubber/fabric boot. The unusual design choice was that the main gear strut was cabled to the top of the spring, while the nacelle was cabled to the bottom of the spring. In flight, the main gear strut hangs in tension, but remains sprung on the compression spring instead of being on a hard stop.

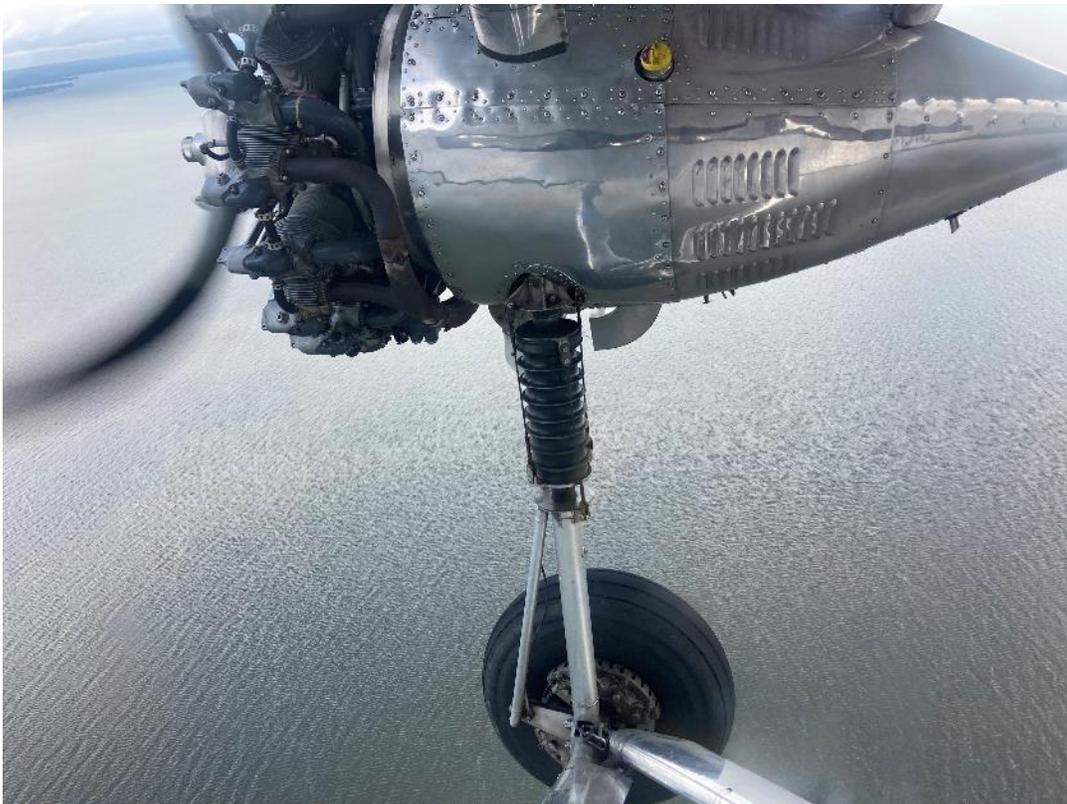
Landing Gear extended in flight. Note tight cables. Lake Winnebago in the background

A continued turn lined us up on base for runway 18R. We turned final and proceeded to a smooth touchdown. I watched as the weight of the aircraft transitioned from the wings to the landing gear, smoothly compressing the big spring.

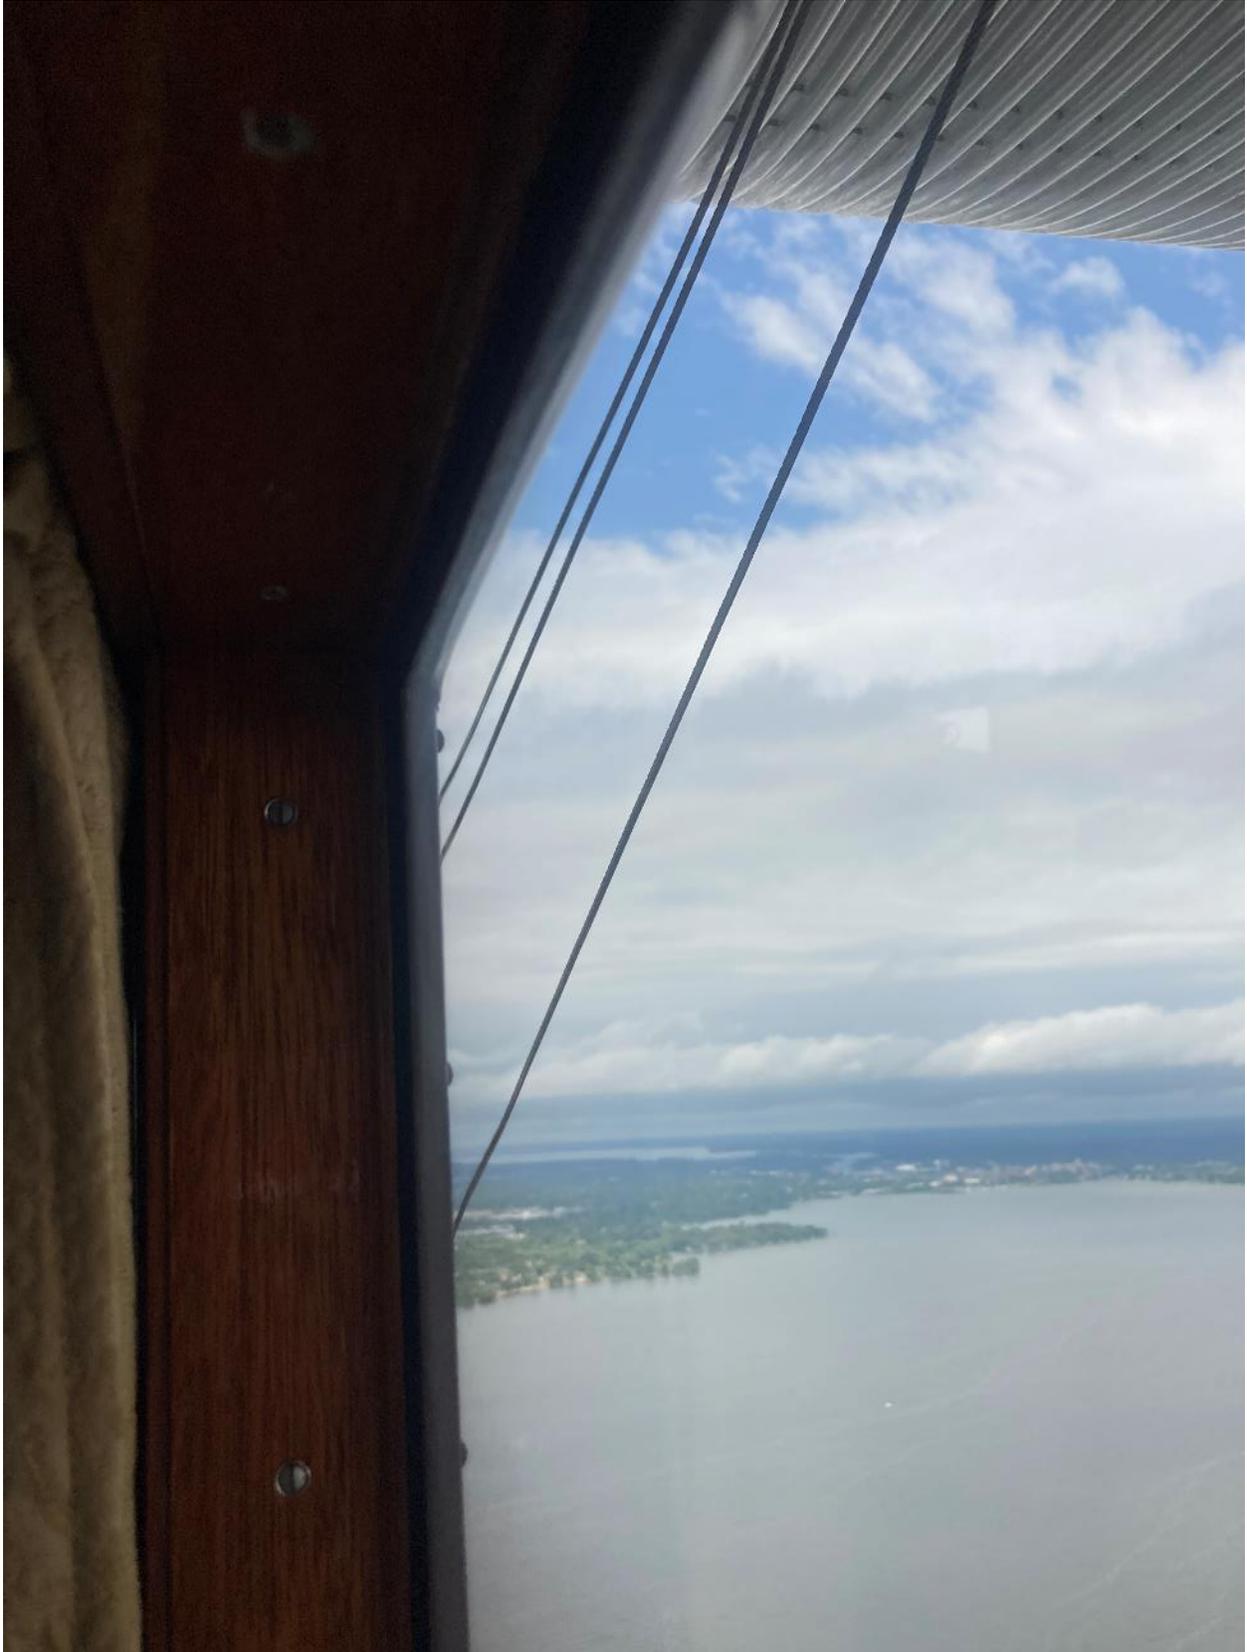
Control cable in-flight inspection
